This program will address the most common system problems associated with the A&E Patio Awnings supplied by The Dometic Corporation. Our intent is to provide you with a guideline of checks to make, should you encounter one of the following symptoms.

SECTION 1 HARDWARE COMPONENTS

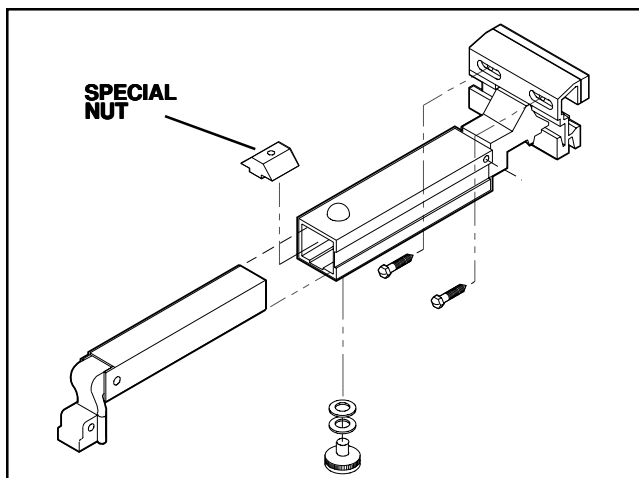
1.1 NUTSERT OR SPECIAL NUT

The **nutsert** is simply a threaded fastening device used to tighten down the black adjustment knob. If the knob will not tighten, first remove the secondary rafter assembly from the hardware. Turn the knob to determine if the nutsert is stripped or spinning. If so, replace the nutsert. If you cannot turn the knob it will be necessary to replace both the nutsert and the black adjustment knob.

On some arm assemblies the nutsert has been replaced with a **SPECIAL NUT**. If the knob will not tighten, first separate the rafter assembly. Turn the knob to determine if the special nut is stripped. If so, replace the special nut. If you cannot turn the knob, it will be necessary to replace both the special nut and the back adjustment knob.

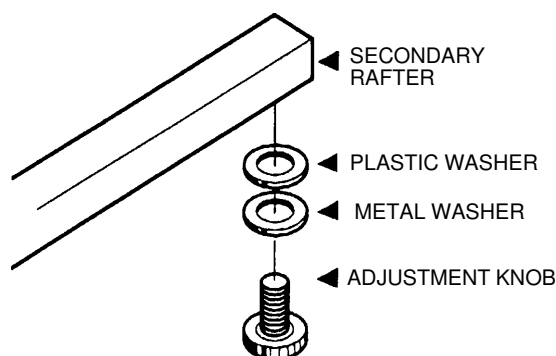
1.2 WASHER STACK-UP

Washer stack-up merely means the proper positioning of the washers on the stud of the black adjustment knob. Remove the knob and check for proper washer position. The plastic washer should be against the main rafter, and backed by the metal washer for stiffness. If the stack-up is not proper it should be corrected.

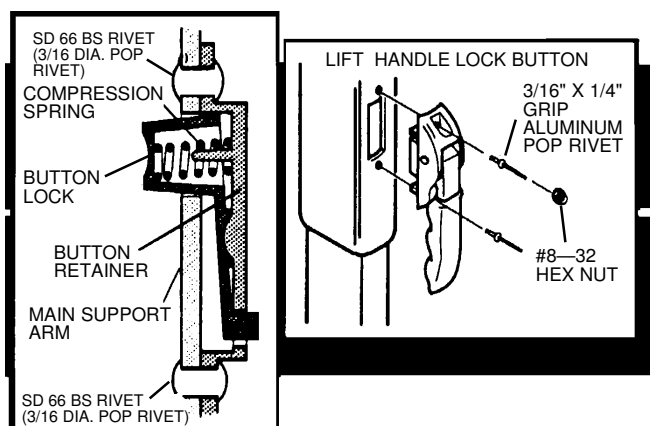
1.3 PUSH BUTTON ASSEMBLY

The push button assembly locks the main support arm to the adjustable arm assembly and controls the height of the awning in the open position. To check it, open the awning to full extension. Look inside the main support arm, and activate the push button to see if the locking pin is moving in and out of the hole in the adjustable arm assembly. If the locking pin does not move, or has been

broken off, the push button assembly must be replaced. At times the lock pin of the push button assembly can break off and jam between the push button housing and the adjustable arm assembly, making it difficult to extend the main support arm.

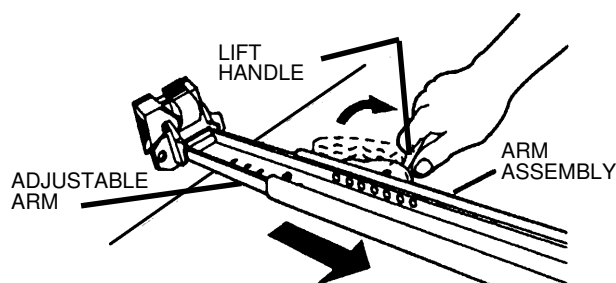
1.4 ADJUSTABLE ARM ASSEMBLY

The adjustable arm assembly allows for telescoping height adjustment of the main support arm, and it connects to the bottom mounting bracket to support the weight of the awning. If the main support arm cannot be extended freely, the adjustable arm assembly should be checked. Remove the adjustable arm assembly and check for nicks, burrs, bends or twists. If any deflection is noted, the adjustable arm assembly must be replaced. For ease of operation apply GO-EASY, a special lubricant.

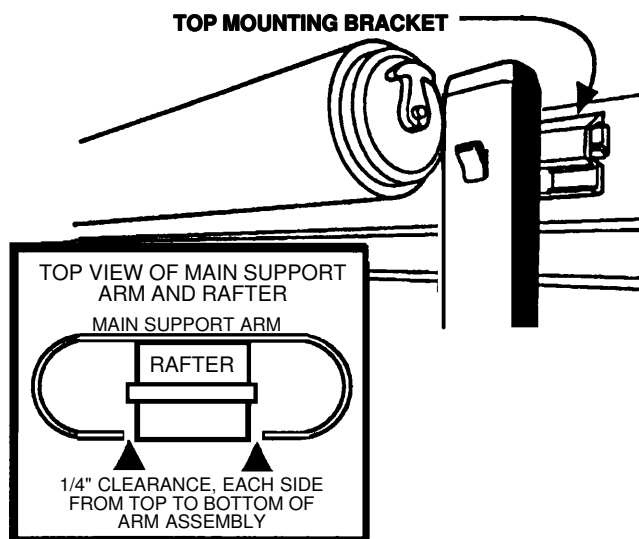
1.5 TOP MOUNTING BRACKETS

The top mounting bracket supports the main rafter assembly to hold the awning in the open extended position, and allows the rafter to pivot into the "C" channel of the main support arm. Each top mounting bracket should be mounted directly over the awning rail so the screws go through the "C" portion of the rail.

On the Series 9000 awning the top mounting bracket can be mounted lower when possible. If the top mounting bracket is mounted above center of the awning rail, the aluminum guard may not cover the fabric completely in the closed position. If this is the case, relocate the top mounting bracket accordingly.

The top mounting brackets have slotted holes for the mounting screws, allowing them to be adjusted side to side. To adjust the brackets, close the awning and sight down the main support arm and the main rafter. The clearance on each side of the rafter should be approximately 1/4 inch. If clearance is not appropriate, adjust the top mounting bracket(s) as necessary.

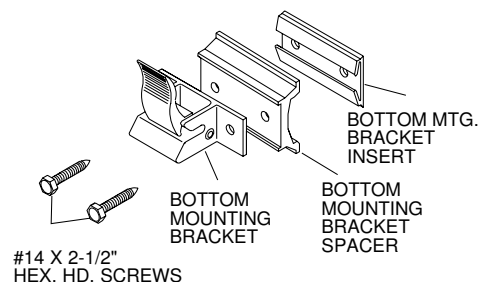
1.6 BOTTOM MOUNTING BRACKETS

If a bottom mounting bracket settles, sags, or becomes loose it can reduce the clearance between the top casting of the torsion and the extension of the top mounting bracket, making operation difficult.

Check the bottom mounting bracket for looseness or settling, and tighten or reposition it accordingly for proper operation.

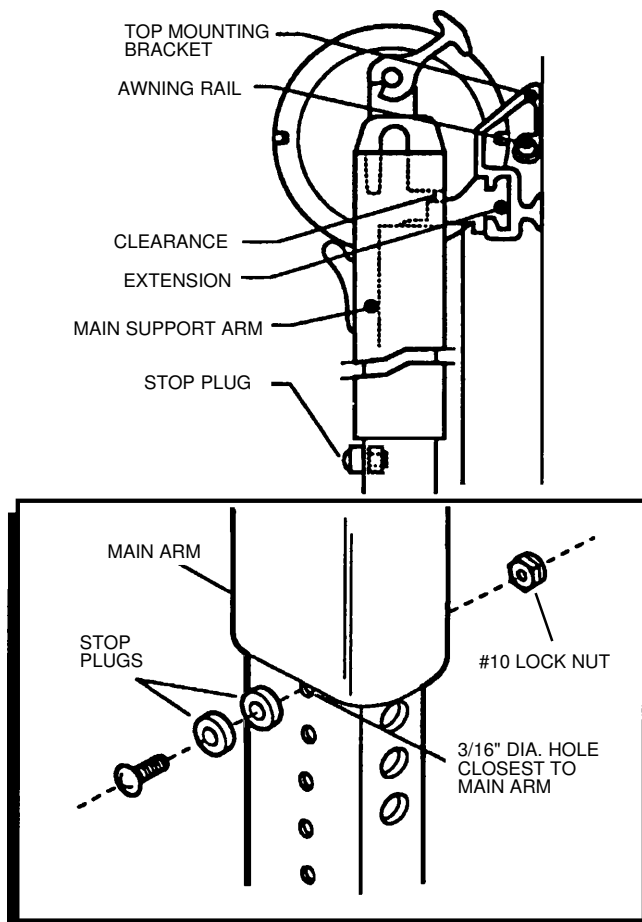
1.7 STOP PLUG

The stop plug is a mechanical stop that supports the main arm when opening and closing the awning. It controls the clearance between the top casting of the torsion to the extension of the top mounting bracket. This clearance should be 1/4 inch to 1 inch. To adjust the clearance, raise or lower the stop plug as needed. On the 9000 and 9500 Series awning the clearance should be kept to a minimum for best operation.

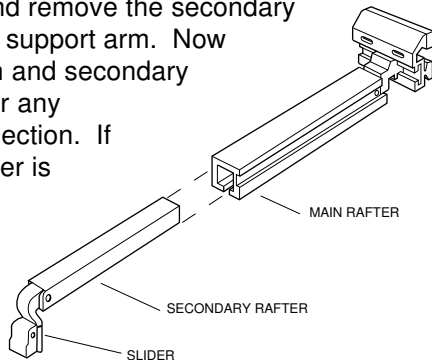
1.8 RAFTERS

The rafters telescope from the top mounting brackets to the main support arms to provide tension on the fabric in the full open position. If the rafters are bent or twisted, this will hinder the operation of the awning. Open the awning and remove the secondary rafter from the main support arm. Now sight down the main and secondary rafters and check for any bends, twists or deflection. If one or the other rafter is not true it should be replaced.

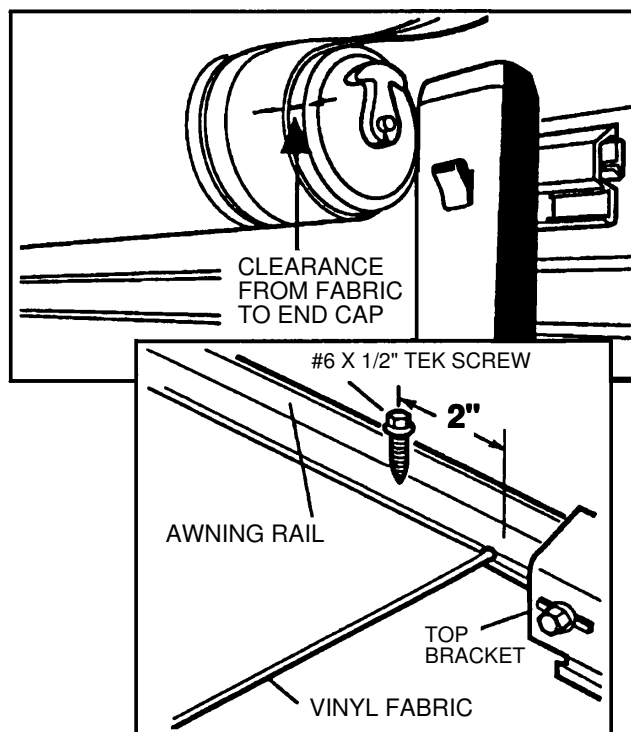
2.1 POSITION

For the awning to operate properly the fabric must be positioned properly in the awning rail and on the roller tube.

Open the awning and check the position of the fabric between the top mounting brackets. If the fabric is not centered, remove the tek screws, center it, and replace the screws.

When the fabric is properly positioned, next check the position of the fabric on the roller tube. The clearance from the end cap of the torsion assembly to the edge of the fabric must be the same on each end. If it is not, adjust the fabric on the tube as necessary.

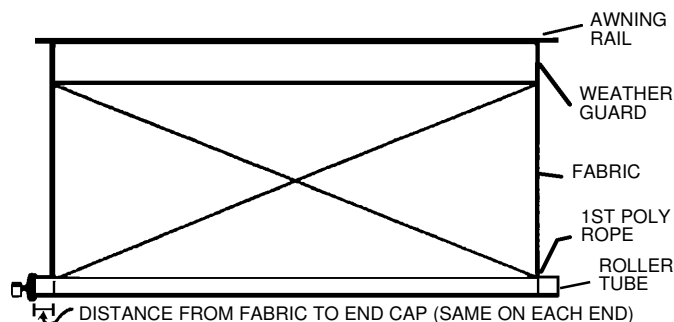
2.2 SQUARE

If the fabric on the awning is out of square, it could cause the fabric to telescope in one direction when rolling up, or to not hang properly in the open position.

To check fabric for square, measure from the top right hand corner of the fabric (not the weatherguard) to the bottom left hand corner at the poly rope. Now measure from the top left hand corner to the bottom right hand corner as shown below.

In this check, the difference of the two dimensions should be no more than one inch. If it is more, the fabric is out of square, and replacement would be necessary.

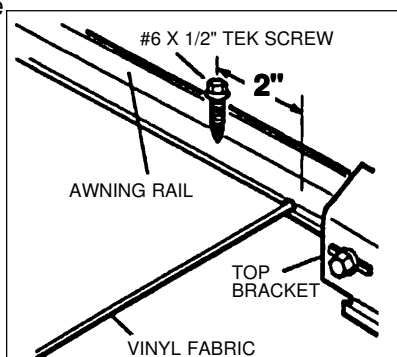
2.3 WEATHERGUARD

When the vinyl weatherguard or fabric has excessive wrinkles, it will be necessary to stretch the weatherguard or fabric. Open the awning and allow the fabric to warm up. Remove one Tek screw, grasp the weatherguard, stretch it, and resecure the screw. Repeat this procedure for the other end, making sure to stretch each side an equal distance, keeping the fabric centered between the top mounting brackets. Close and reopen the awning three times. If wrinkles are still present, repeat the above stretching procedure. This may have to be done 4 or 5 times before all wrinkles disappear.

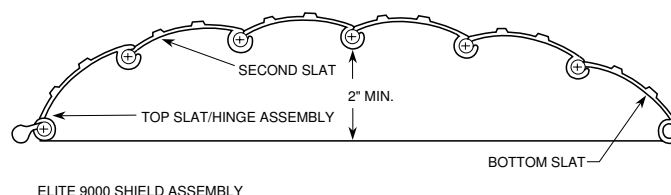
2.5 ALUMINUM GUARD

When the awning is fully extended, the aluminum guard should have an arch of at least 2 inches. The arch helps water to run off rather than between the sections of the guard.

To check the aluminum guard for proper arch, open the awning to full extension, making sure the fabric is taut. Hold a flat edge to the bottom of the guard and measure from the flat edge to the inside of the arch at its highest point. If the measurement is less than 2 inches, the guard should be replaced.

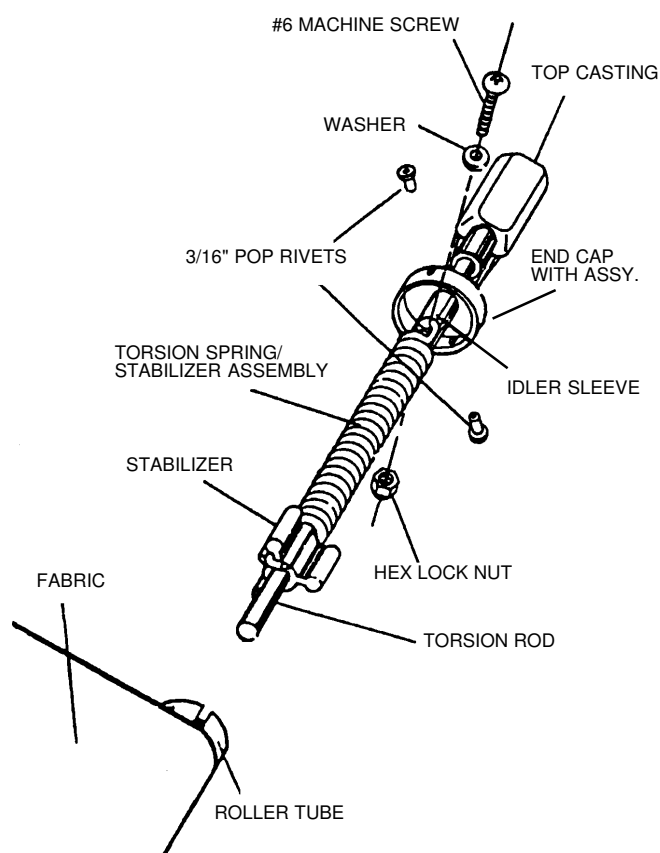
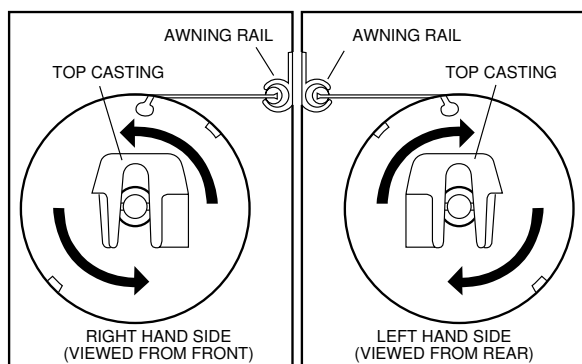
2.8 TORSION

When difficulties are experienced in rolling the awning up, the tension on the torsion should be checked. In

most cases adding a few turns of torque to each end will correct the problem. If all tension has been lost, refer to the following chart and apply the specified number of turns as indicated. This must be done with the awning extended two feet away from the coach.

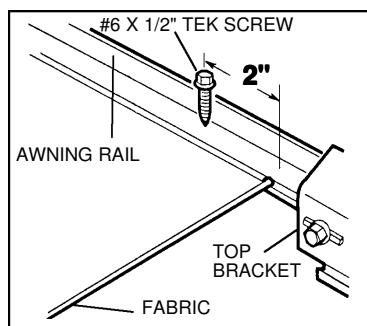
2.12 TEK SCREWS

The Tek screws are the two screws installed through the awning rail of the coach. They keep the aluminum guard from shifting in the awning rail. On vinyl and some acrylic awnings (see Sec. 2.5) they keep the fabric from shrinking with age. If one Tek screw is missing, the fabric will pull toward the remaining Tek screw causing the fabric to wrinkle.

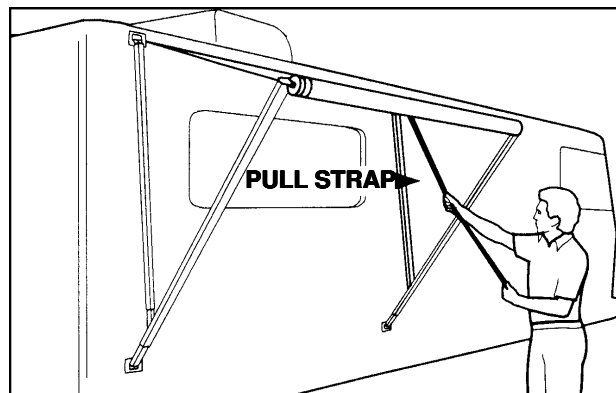
3.2 CLOSING

On the 9000 and 9500 Series, when rolling up the awning, the roller tube assembly should not be slowed down before reaching the aluminum guard. This could cause the roller tube to stall at the guard.

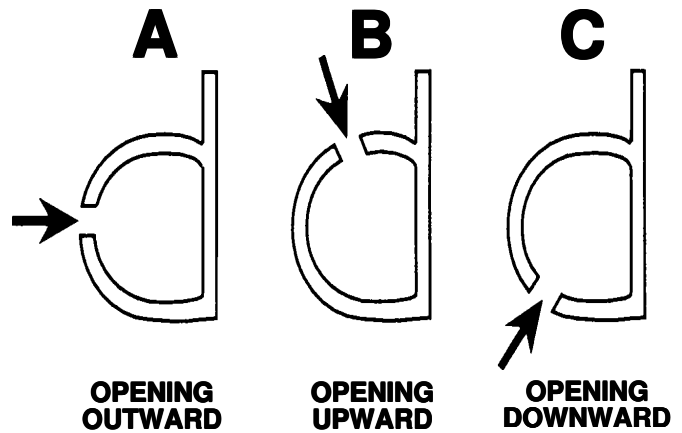
4.3 TYPE

There are three types of awning rail used in the RV industry. Of these, type A and B (see below) are acceptable for use on the 9000 Series awning that utilizes a hinge slat (see Sec.2.5) . Type C should never be used on the 9000 Series that utilizes a hinge slat (see Sec. 2.5) as it could cause a binding problem on the aluminum guard assembly, but it is acceptable on the vinyl awnings.
