2002, 24 foot Hi-Lo Camper Window, Wall and Beam Restoration

Summary: Last summer (2013) we were on a camping trip and raised the day-night shades when we arrived at the campground. Unfortunately, one of the screws for the restrainer cords that holds the shade down, pulled out of the trim cap above the upper section beam and we discovered that the beam was rotted. Turns out the manufacturer over-cut the opening for the windows in the walls and they leaked and rotted both the lower section of the walls below the windows and the perimeter wood beam below. Twelve and a half feet of beam was rotted on one side and five feet on the other side. The window under the awning was just as improperly installed but the awning protected it from the rain. The window manufacturer says the minimum required overlap between the window and wall is 3/8". Unfortunately, there were places around the window which had less than 1/8" overlap. The windows looked great from the outside and inside but they were not installed correctly. The windows were installed using putty tape between the frame and the wall and with so little overlap; the putty squeezed out and allowed water to enter. For five weeks my wife

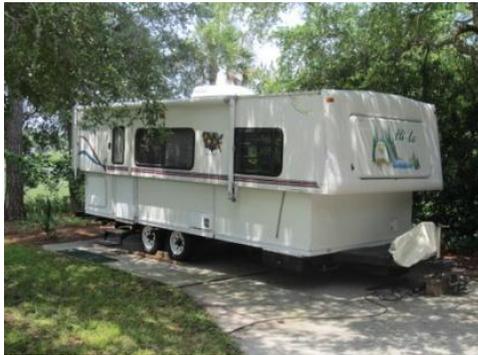
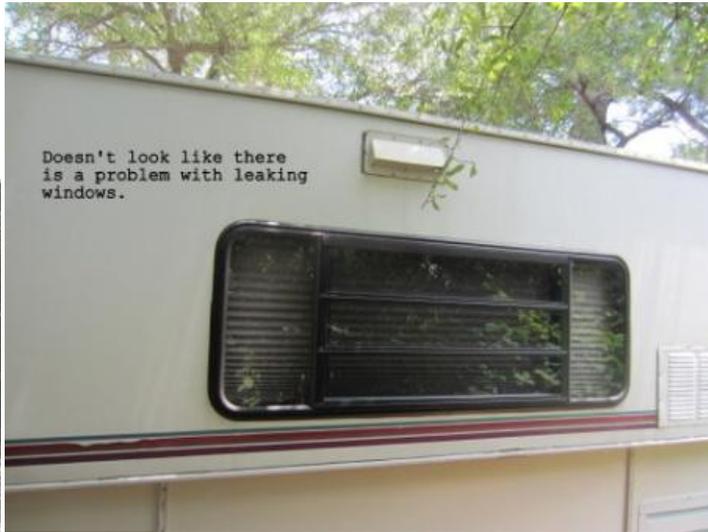
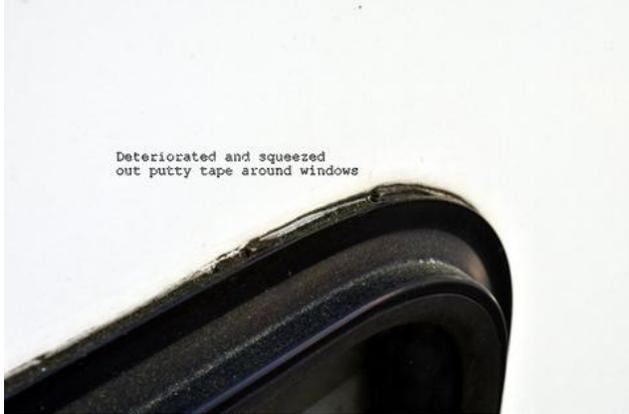
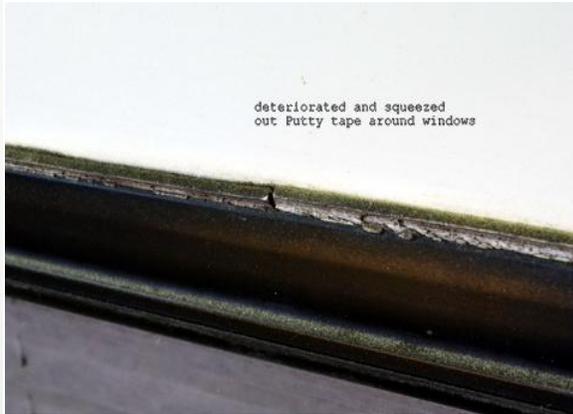
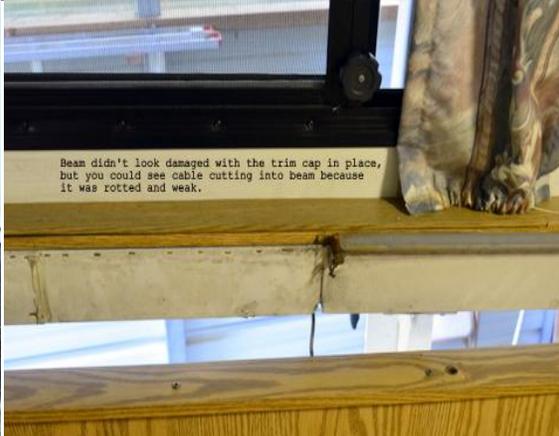
Images of putty squeezed out around windows

The last photo above on the right is showing the top and bottom halves of the camper separated and the aluminum covered beam at the bottom of the upper half. The lift cable cut through the aluminum beam cover because the beam was rotted and weak.

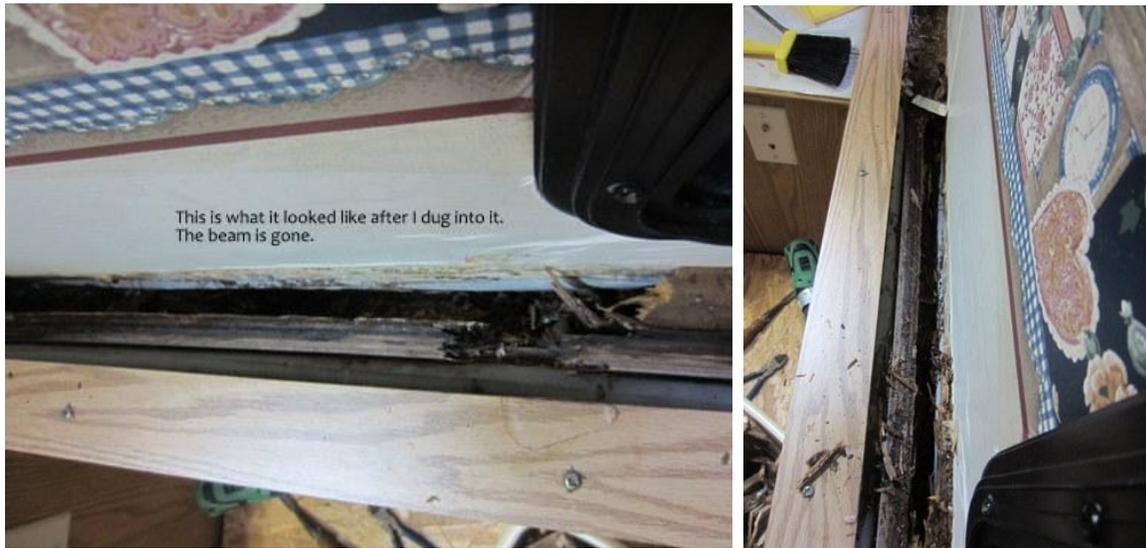
This is what the leaking caused: The photos below are looking down at the rotted beam and wall intersection between the upper wall and the lower wall where the beam was covered by a trim cap.

Not only is the beam shown above rotted, but the entire wall below the window was also rotted behind the vinyl wall covering.

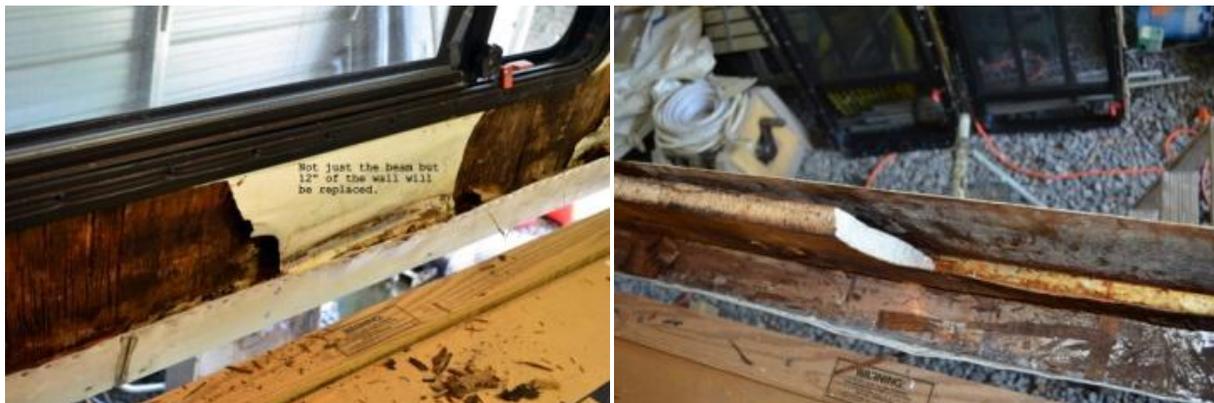
You can see in the photos above that the composite camper wall, consisting of 1/16" fiberglass outside skin, 1/8" plywood, 1" of foam, and 3/16" plywood inner wall was rotted and delaminated below the windows. The photo on right is looking down into the wall where a window was removed, with the rotted wood beam and portions of the wall also removed. The remainder of the 1" foam insulation below the window opening in the photo will be removed to rebuild the wall.

In order to accomplish replacement of the wall, beam and bulb seal, the upper and lower sections of the camper must be separated. Follow the procedure below to **separate the top and bottom halves**:

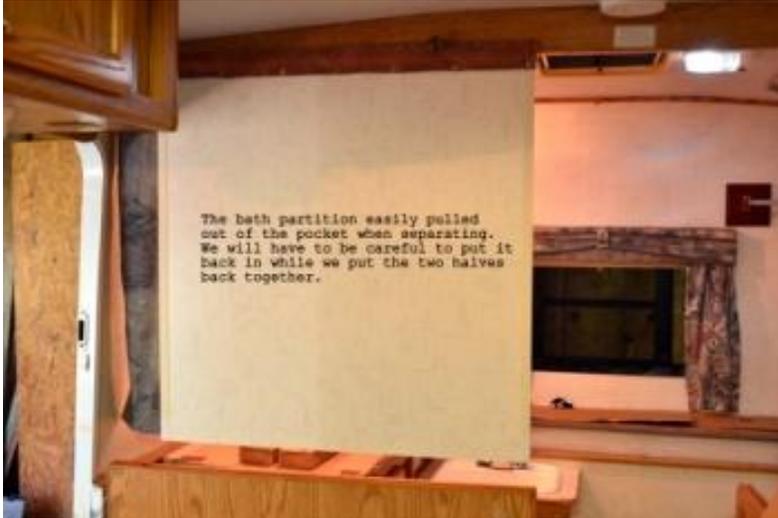
1. My 24' Hi-Lo has a wood pocket wall separating the bathroom from the rest of the camper, I just let the walls slip out of the pocket, but it is essential to pay attention when they are about to go back into the pocket while you are putting the two halves back together or you could jamb them and break them if they are not lined up properly. You may need to or want to remove screws holding the upper section of the pocket wall, remove the walls and reattach them after you put the camper halves back together.

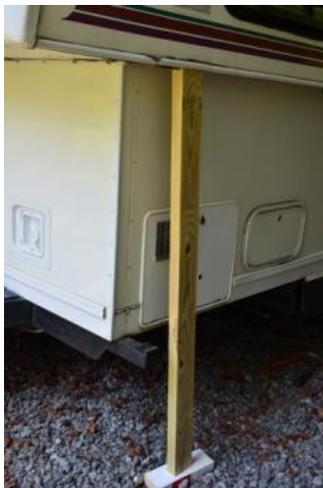
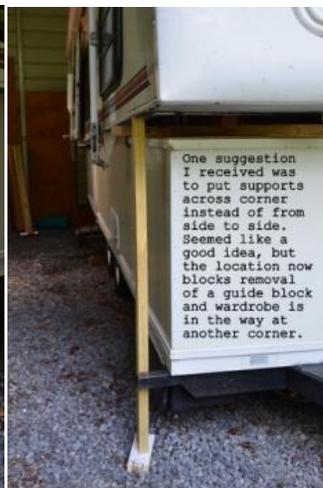
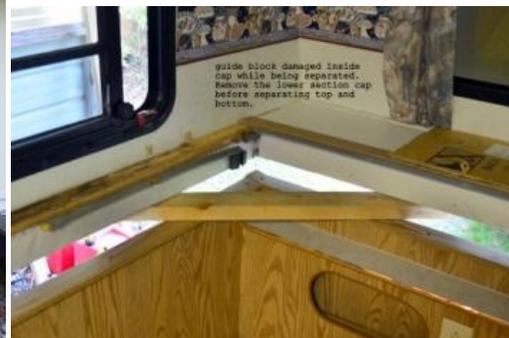
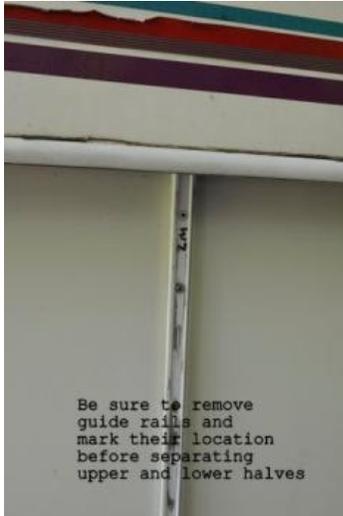
Some issues shown below: Photos 1&2 show 2x4 vertical brace in place for separating top and bottom halves. Photos 2 & 3 discuss use of a 2x4 corner support rather than 2x4s from side to side, note the corner support in photo 3 and the guide block which I could not access with a screw driver to remove. Photo 4 is a guide rail, all of which must be removed. Photos 5, 6 & 7 show the damage that can happen if you DON'T remove ALL the trim cap from the bottom wall and ALL the guide rails. The guide rails will hold the guide block flush against the wall and when the two halves separate, the guide block will tear up the seal trim and the lower wall trim cap. (I was unable to access the top screw on one of the guide rails and though it would be okay to leave it in..... NOT) If I had it to do over again, I would have jacked that corner of the camper up with a car jack if necessary to remove that last screw.

Be sure to remove guide rails and mark their location before separating upper and lower halves

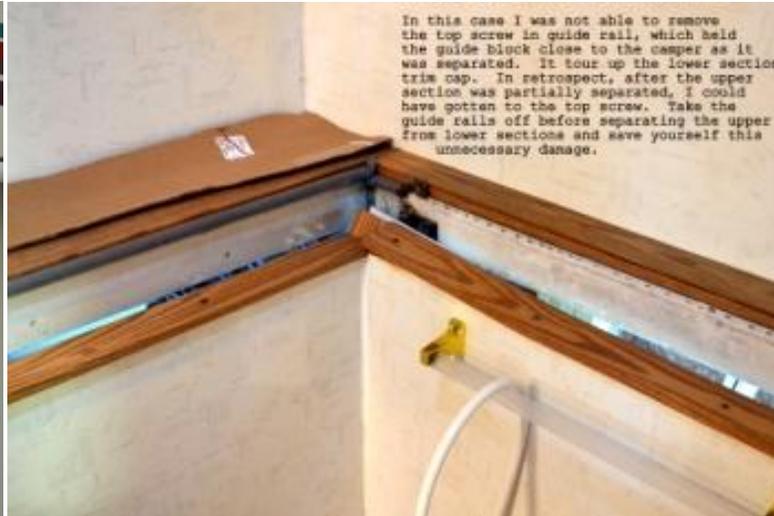
In this case I was not able to remove the top screw in guide rail, which held the guide block close to the camper as it was separated. It tore up the lower section trim cap. In retrospect, after the upper section was partially separated, I could have gotten to the top screw. Take the guide rails off before separating the upper from lower sections and save yourself this unnecessary damage.

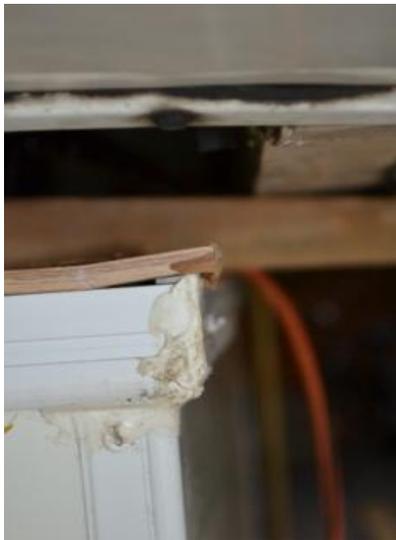
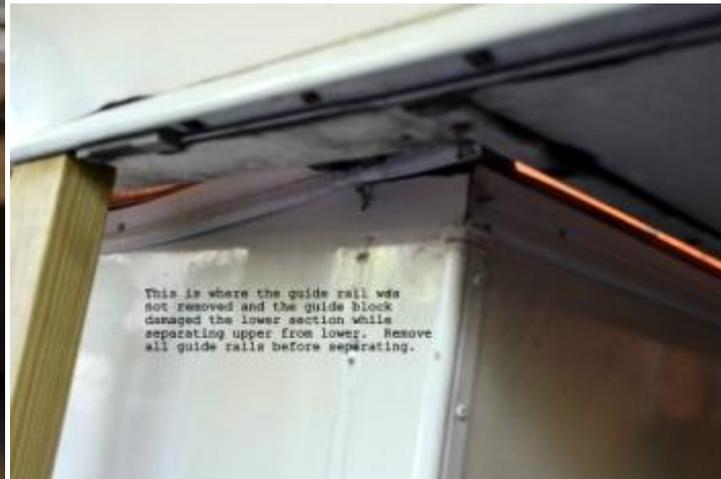
This is where the guide rail was not removed and the guide block damaged the lower section while separating upper from lower. Remove all guide rails before separating.

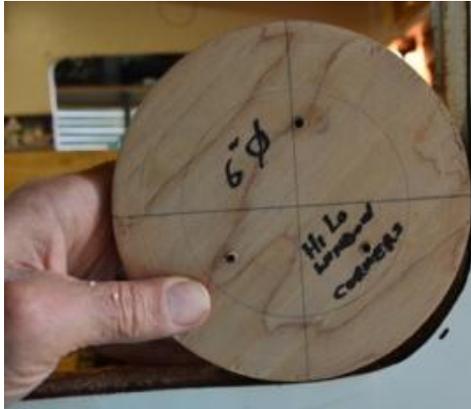
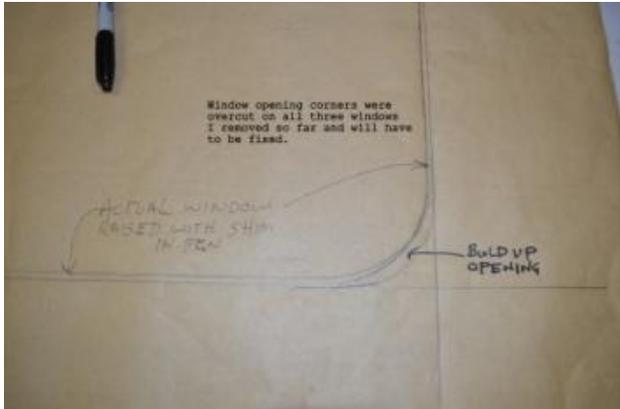
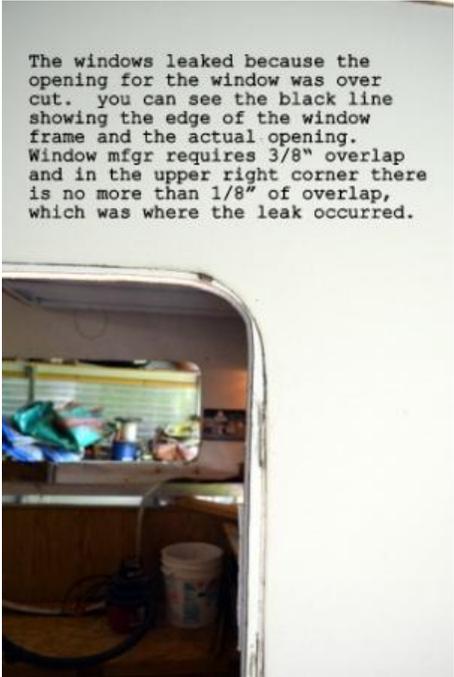
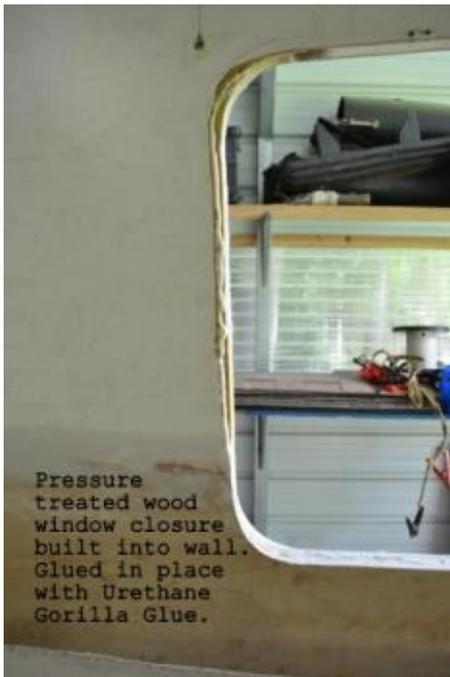
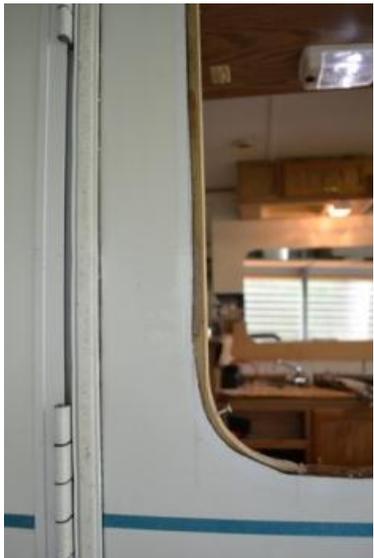
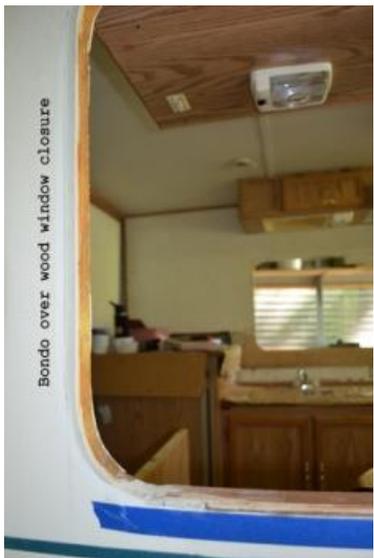
Window issues: The original window openings in the wall were overcut, both in the corners as well as top to bottom and side to side dimension. The window manufacturer requires a minimum overlap of the frame and wall of $\frac{3}{8}$ " and there were places where there was less than $\frac{1}{8}$ " overlap. I cut a 6" diameter circle to match the window corner curve to help determine where the corners should have been cut to. I then drew the actual window opening by taping a piece of paper against the camper wall on the outside without the window in place and drawing the opening from the inside. I then laid the window on the drawing and outlined the window to determine where and how much I needed to reduce the opening to achieve a minimum $\frac{3}{8}$ " frame overlap all the way around but still have sufficient clearance to install the window. (You don't need much clearance; the opening just has to be cut accurately.) I cleaned up the window opening on one side to make it accurately match the window requirement and then I made a 1" thick Pressure treated wood insert to match the required corner curves, height and width for the opening and dug out the foam insulation on one side of the window opening to the necessary depth in order to insert the pressure treated closure piece into the wall. I then built up the top to bottom dimension by adding pieces of wood at the bottom of the opening as necessary. Since the inserts did not come out flush with the wall of the camper and to make the seal water tight, I put Bondo over the inserts to bring them flush with the camper wall for a tight seal.

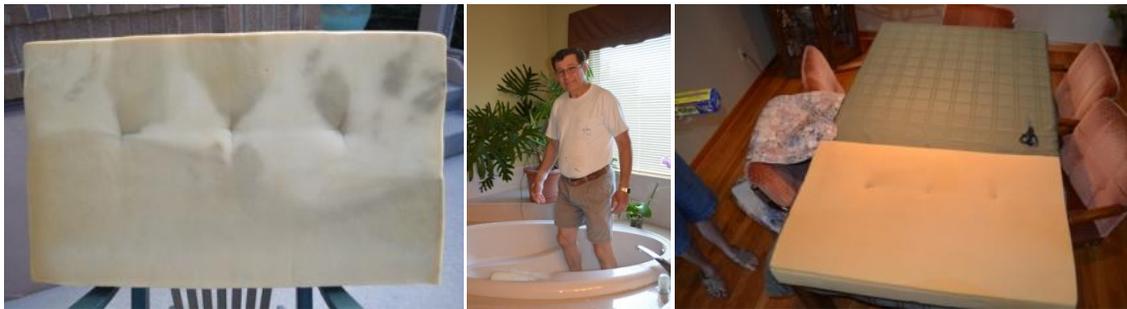
Because the camper had moist walls from rotting wood, there was always a musty smell in the camper. We thought it had to do with the fact that we live along the coast and it is very humid here, but now we think it was the rotting moist wood that was causing the mold and musty smell. So we took all the cushions out, took them apart and washed the covers and tried to treat the musty smell in the foam with baking soda and then vinegar. This procedure helped a lot, but the cushions for the dinette obviously has something spilled on them and we could neither get the stain or the odor to abate. We figured we would have to replace the foam anyway and had nothing to lose by trying to immerse them completely in the tub to see if that would clean them. I did the grape dance with warm water and laundry soap and it did the trick. The washing got them clean and odor free. It did however; take several weeks in the sun and breezy fresh air plus squeezing the cushion between towels to get them dry again.

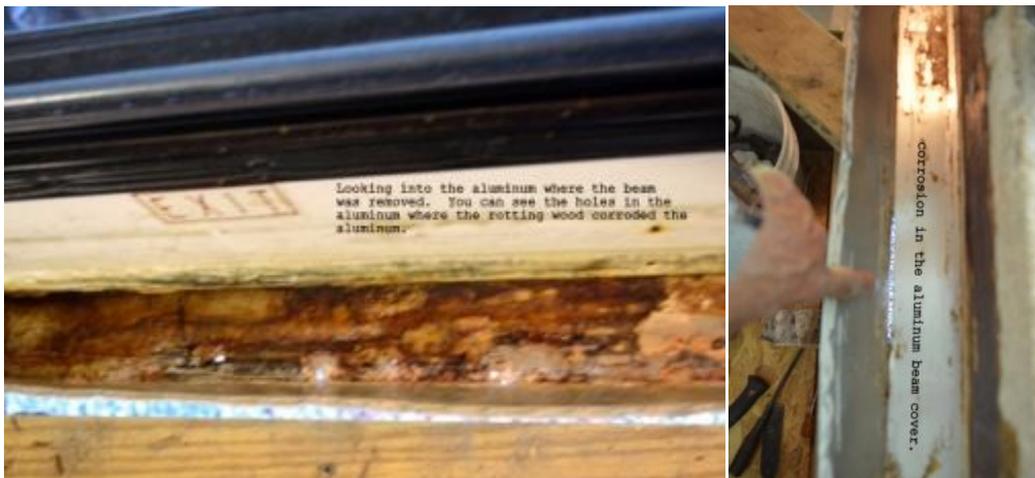
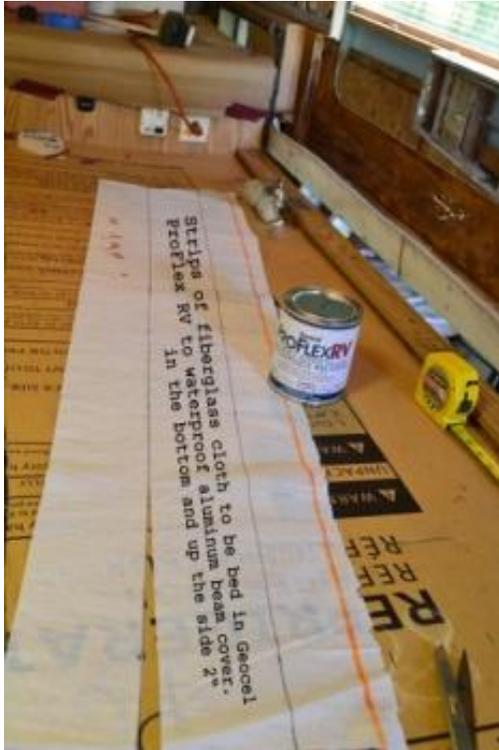
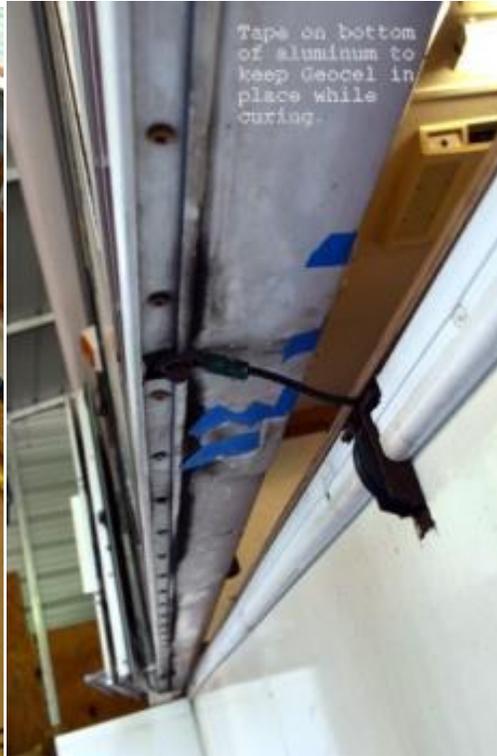
As the beam rotted in the aluminum housing, tannic acid from the wood leached out and attacked the aluminum. The photos below are looking into the aluminum beam cover with the rotted wood beam removed. We cleaned the stains off the aluminum with Goof Off and Awesome. In doing so we realize the aluminum had pin holes where the acid had eaten through the aluminum. Holes in the aluminum were also evident where the manufacturer had used galvanized staples through the aluminum into the beam. We decided to use Proflex RV sealant and bed a fiberglass cloth into the sealant to give the finished product strength and watertightness. It seems to have worked well, although I did need to modify my replacement beam to compensate for the new material I added to the beam space within the aluminum cover.

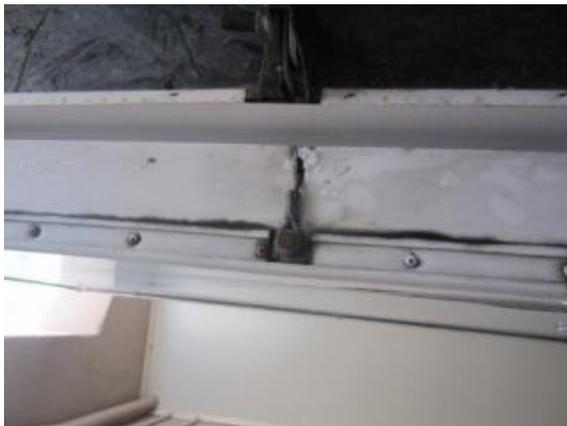
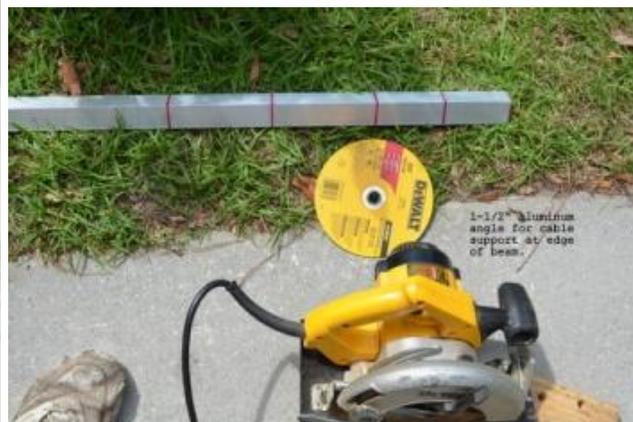
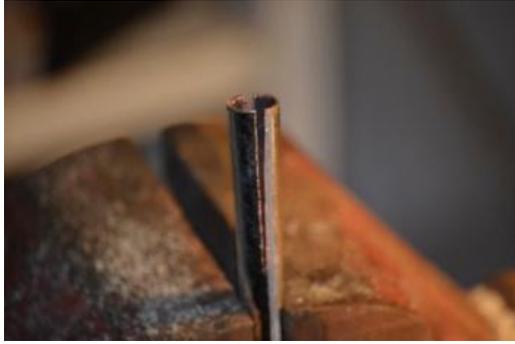
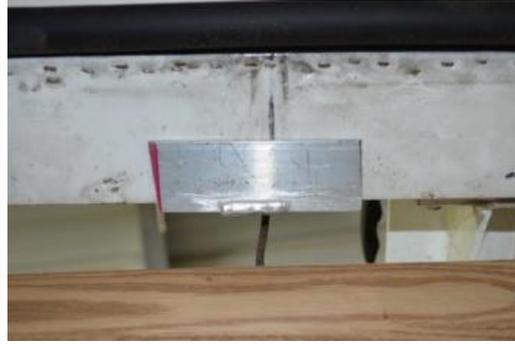
Where the beam rotted, the stress from the lifting cables cut through the aluminum cover into the weakened beam (photo below). It was a bad design to wrap the cable around the aluminum covered beam without any additional means to distribute the load on the beam. On my friend's 2005 28' Classic Hi-Lo he actually has a rounded bracket mounted on the beam at the cable to take the stress from the cable. I guess Hi-Lo figured out it was a problem after they built my camper. So I got a piece of 1-1/2" x 1-1/2" stock aluminum angle and cut it into 4" sections. I then took a piece of chrome plated copper tubing and split it length wise. I filled the copper tubing half rounds with marine epoxy putty and fitted them onto the corner of the angle. I attached them centered on the cable. The rounded corner makes it easier for the cable to turn the 90 degree corner without excessive stress on the cable and the aluminum angle spreads the load out over the beam. Works great.

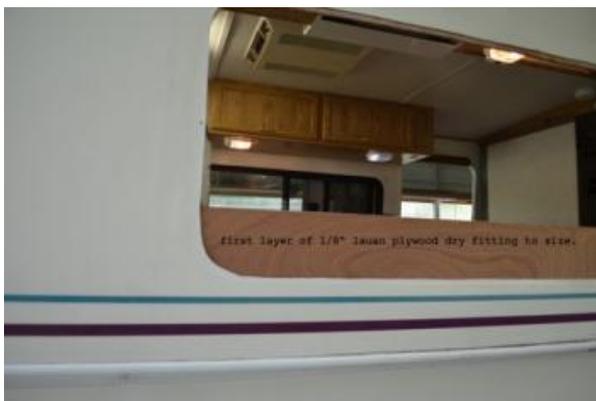
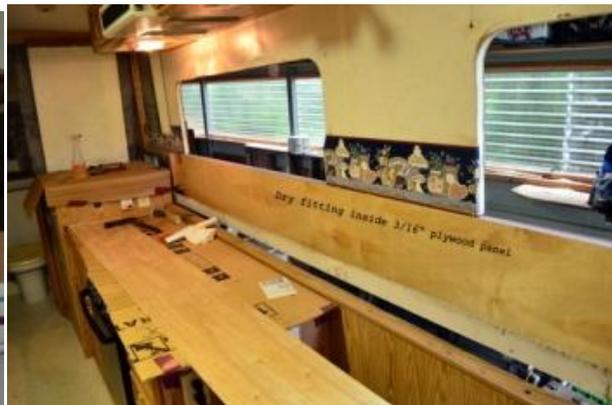
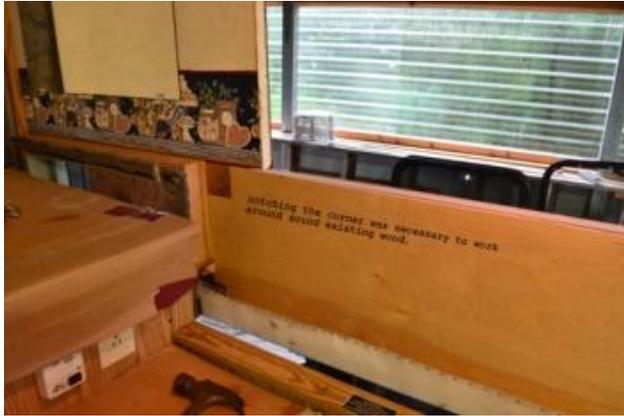
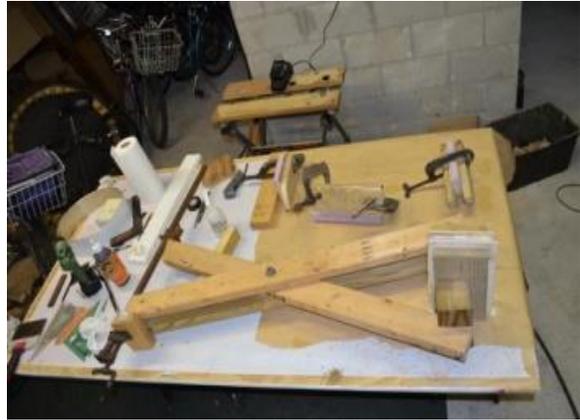
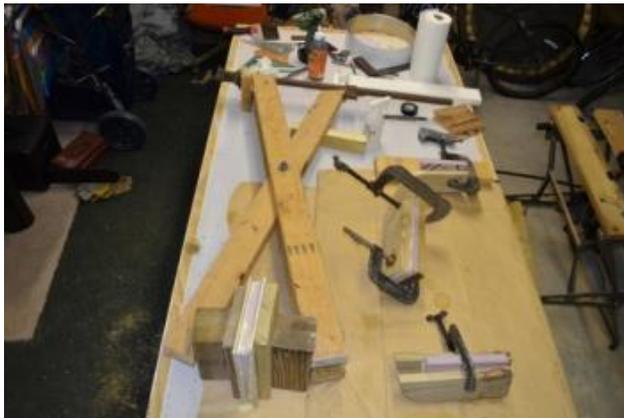
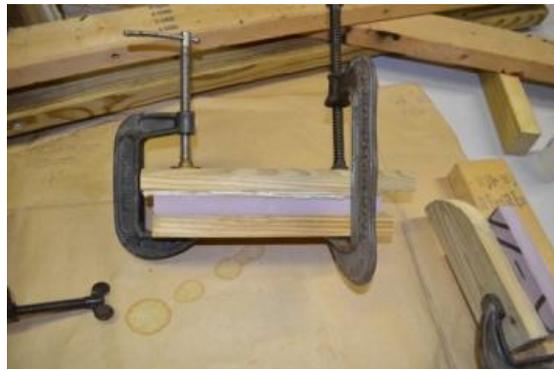
It took a bit of dry fitting things together before we began the process of gluing the walls up. I was concerned about using moisture cured urethane glue (Gorilla Glue) which only allows 15 minutes before the glue sets up and you better have it clamped or you might end up with an unforgiving mess on your hands. Manufacturers who make Structural Insulated Panels, (SIP Panels) use urethane glue all the time, and that is what Hi-Lo used in the factory to make the walls which consist of a 1/16" fiberglass panel, 1/8" plywood, 1" of EPS foam and finally a 3/16" plywood panel all glued together. Dow chemical makes a broad range of urethane adhesives for SIP manufacturing that have a working time of from 15 minutes up to 2 hours depending on the SIP manufacturer's requirements and set up. I contacted them to try to purchase a small quantity for my project and they were not helpful. J&R was also not able to assist. I was forced to use Gorilla Glue with only a 15 minute working time limit. We altered how we would put the pieces together in stages that we could stop and clamp up one section within the time limit and not interfere with follow on sections that we would have to begin after the first section was clamped up. We tried some test pieces to see how close the clamps needed to be to get good pressure on the assembly. We could not find a clamp that would reach 14" in from the throat of the clamp in order to reach the wall section forward of the window opening. Where there was a window on both sides and we could clamp on both ends of a board, we figured we would be okay, but we needed something to extend 14" into the wall from the window opening. So I built the "Clamp-a-Saurus". It is a scissors clamp with jaws that will extend more than 14" beyond the pivot point and the jaws are compressed with a bar clamp on the other end. You can see on the next page, the array of clamps we used to put pressure on the entire wall length.

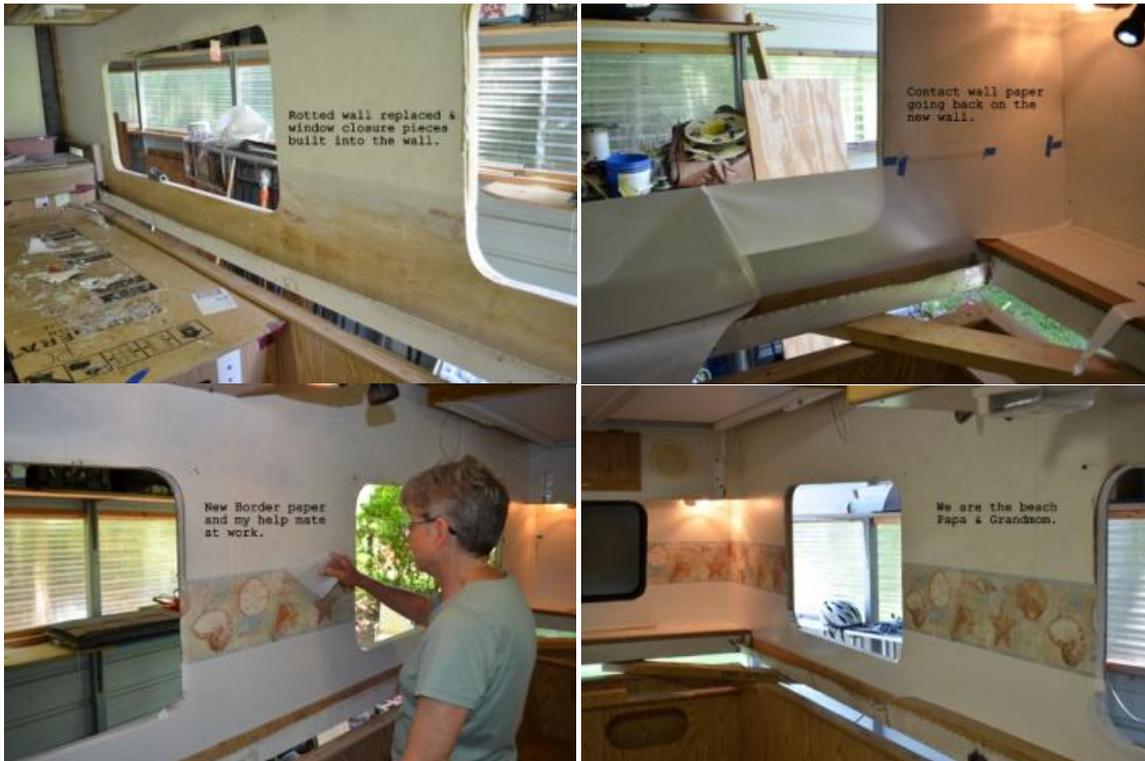
The clamps are off and we are putting on the new wall finishes with new coastal shell boarder.

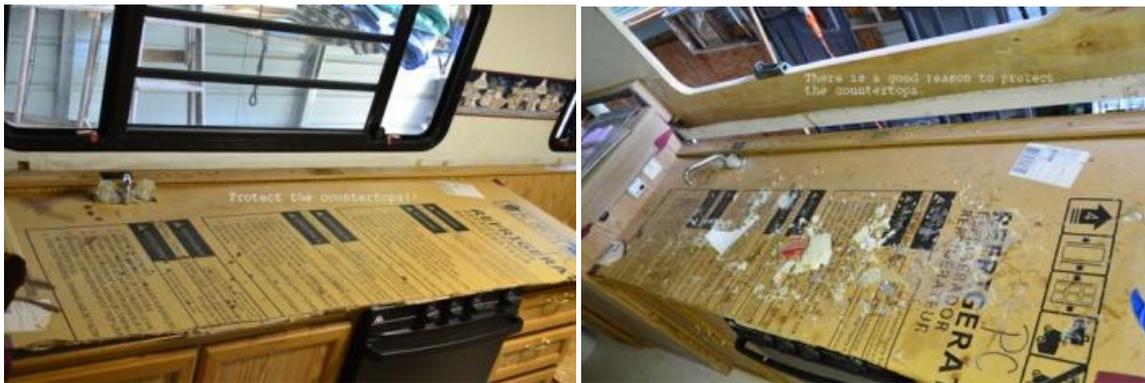
The two photos below tell the story as to why you need to protect your countertop and appliances. The glue and whole removal and reinstallation process is very messy and unforgiving.

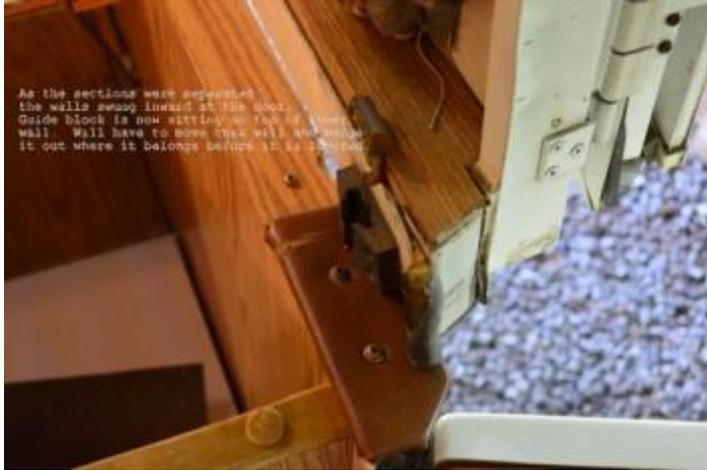
One thing we noticed was that the guide block closest to the door swung in as we separated the top and bottom halves. When we lowered the halves back together at the end we had to put wedges along portions of the walls to keep them in alignment. If we had lowered the top section with the guide block sitting on the lower wall, it would have broken perhaps both the guide block as well as the lower wall.

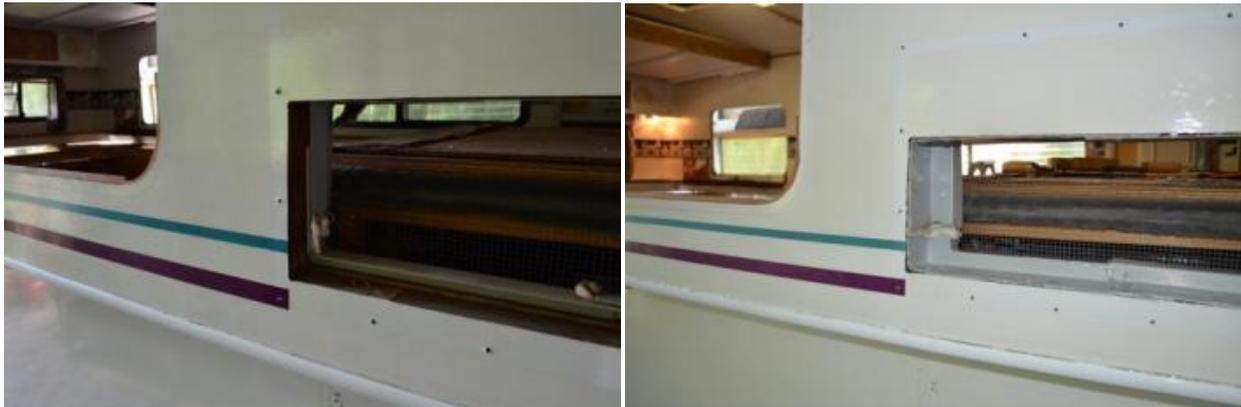
My friend told me to check my vent for the refrigerator. On his 2005-28' Hi-Lo Classic the rain deflector behind his vent cover was installed backward, which caused rain that entered the vent to go into the wall and rear of the refrigerator rather than back out of the camper. The first photo below is what I found when I removed the vent cover. The deflector was installed backward in my 2002 camper as well. The second photo below shows the deflector properly re-installed and sealed to direct rainwater out not into the camper. I hate to say it, but you should probably check yours to see if it is installed correctly. The gray plastic should be sealed around the perimeter and should be installed in such a manner as to act as a dam that directs water out of the camper rather than into the camper.

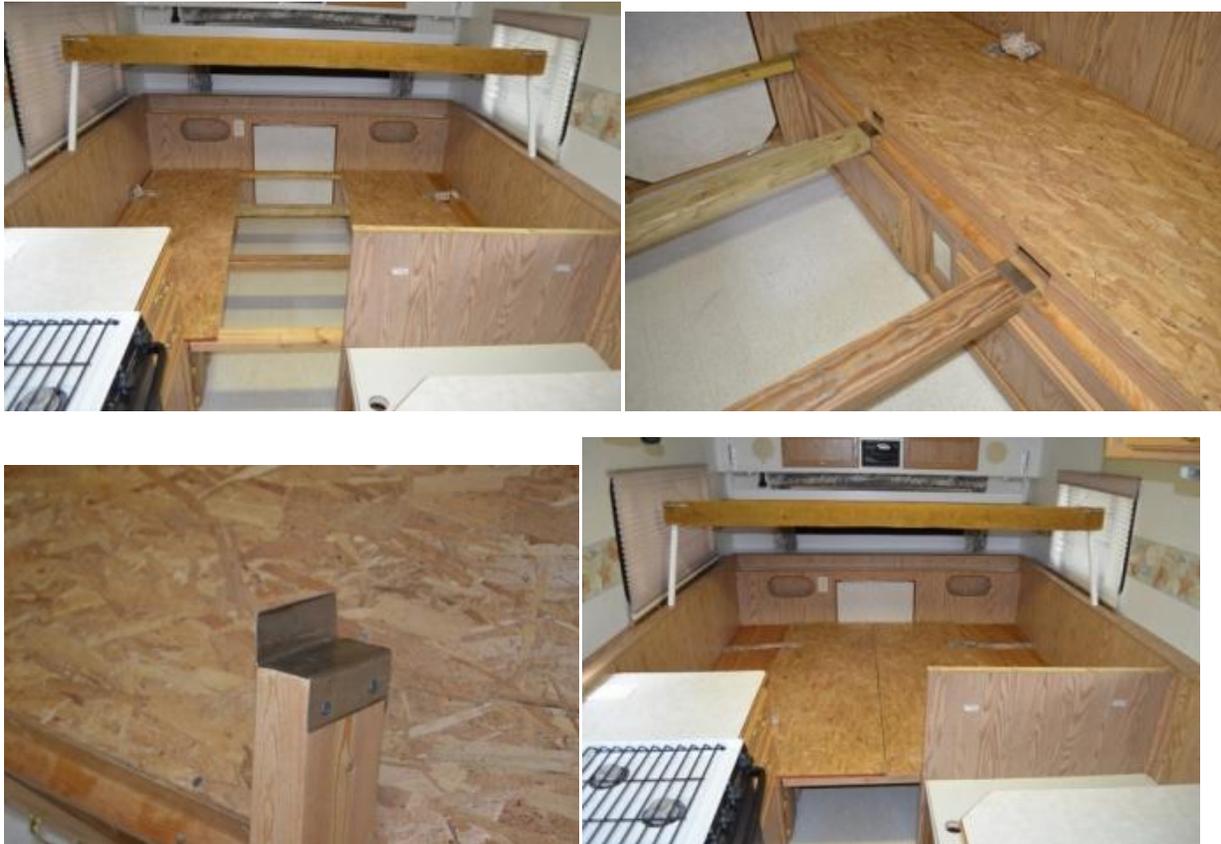
Our 24' camper is set up with 2 facing couches in the front with a drop down table between them. The couches come together to form a king size bed. The way the couches come together is by sliding two opposing pieces of plywood, sitting on top of the seats, together to form a continuous platform for the cushions. However, the front lip of the plywood has several legs that are now sitting in the middle of the walkway between the two couches, blocking access to the storage below the seats as well as possible use of the walkway below the bed. (We also have an overhead bunk above the king bed.) Since we have a lack of storage and there is no place to put the bedding when the bed is made into two couches, we just leave the couches made up as a bed and sit at the dinette. I solved the "legs in the way" problem by removing the legs, and cut 4 pieces of 2x4 to go between the couch seats. I notched the front lip of the sliding plywood panel to accept the 2x4s. On the end of the 2x4s I put a Z shaped bracket made from scrap stainless steel screwed to the bottom of the 2x4 with a lip that sits on the seat. We put the 2x4s in place, slide the plywood panels over the 2x4s and you now have a fully supported platform for the bed without legs to get in the way of access to storage under the seats. We also keep a rolling plastic clothes container and a laundry basket in the walkway under the bed. I use the awning rod to retrieve the rolling clothes container if it is too far under to reach. Storage is so limited in these campers and it is a waste of valuable space to have legs where you could have storage.

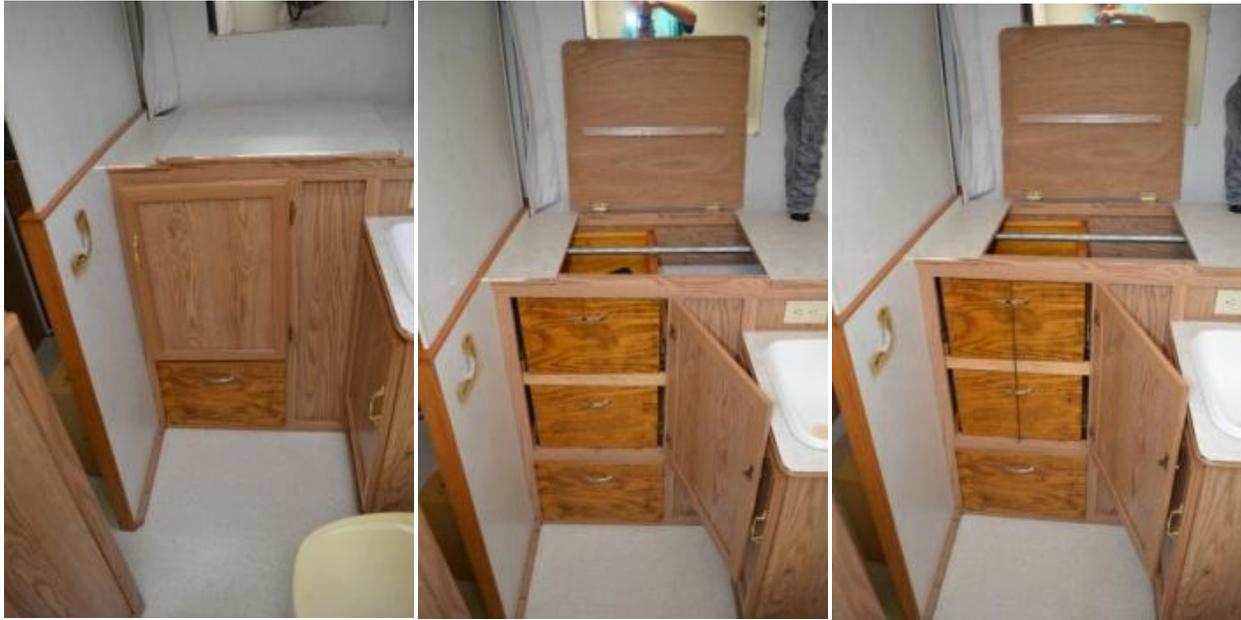
The wardrobe was extremely impractical. All we had for clothes was a small hanging rod. Okay, I got a place for shirts, but what about socks, pants and underwear? We needed more drawer space, even with my modification to provide accessible storage under the bed. So I took some space from the wardrobe and built 3 large drawers. Now we have hanging space and drawers. I added a child safety latch to the bottom drawer and a brass rod that goes through the handles of the upper two drawers to keep them in place while we are traveling.

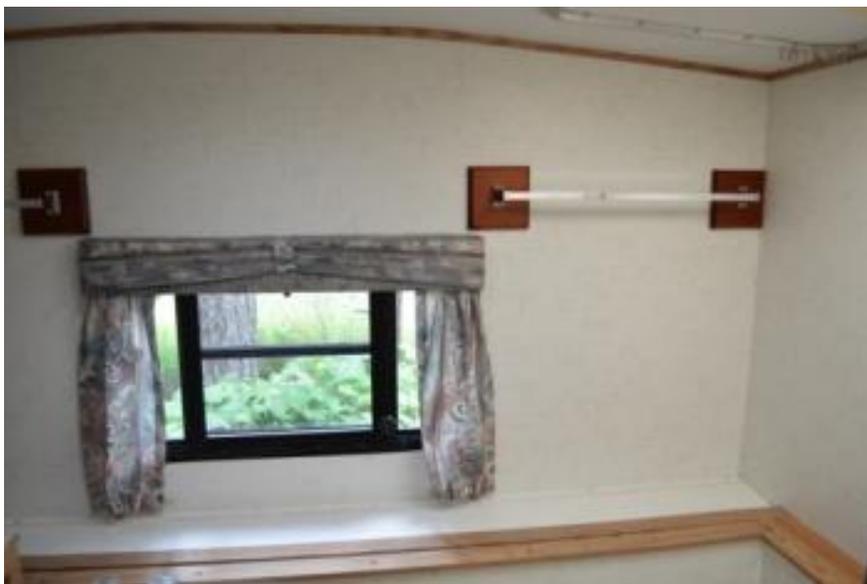
This last photo shows a pair of towel bars I added to the bathroom. There was no place to hang a towel to dry. I cut a 6"x6" piece of cherry as a mounting plate and used construction adhesive. I think I put one screw each through the cherry under the towel bar bracket. They work great!! Hope this gives you some good ideas for your own modifications to make your camping experience more enjoyable and convenient and your Hi-Lo more usable.
