## Adding Safety Chains For a Fail-Safe Support to Our Georgetown Propane Tank

Revised: February 3, 2024 – Added wording about the possible effects of a complete rear bracket failure.

Due to the cracks and outright failures a few people have reported on their later model year Georgetowns, and because we had two cracks on our 2020 GT5, we wanted to add some type of "last resort" protection to keep the propane tank from falling and possibly hitting the pavement while driving.

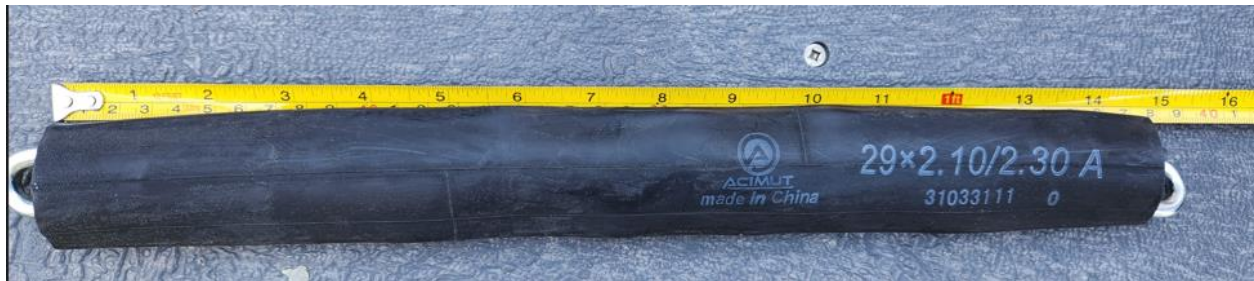
Cut the bicycle inner tube into four lengths, about 15” each. Place the chain lengths inside the inner tube.

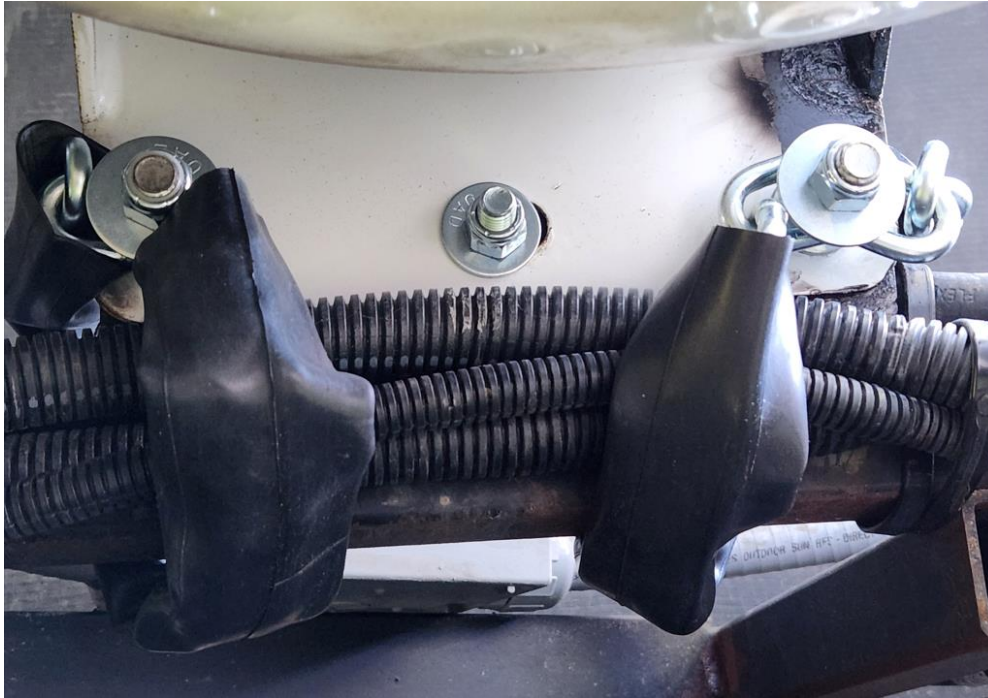
## Rear chains, viewed from underneath

Yes, I just wrapped the safety chains around the wire bundles but **not** over the flexible propane line. It's not a tight fit, as long as the tank does not drop. 😊

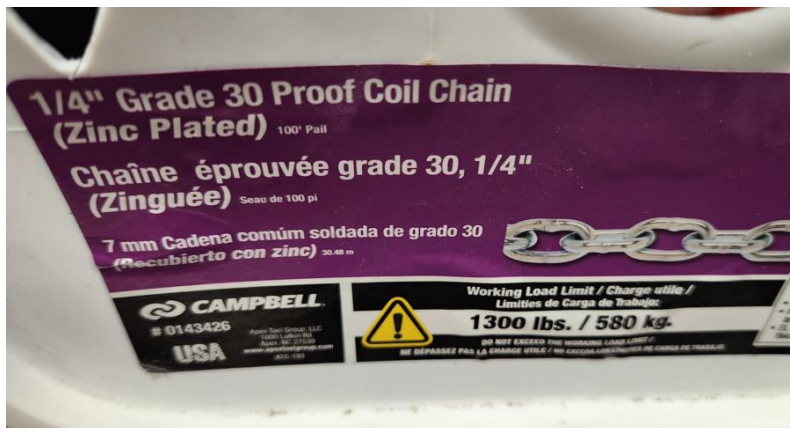
## The chain size I used

The only criteria were that the chain links would fit over the 7/16" tank mounting bolts and that it fit inside a bicycle inner tube.

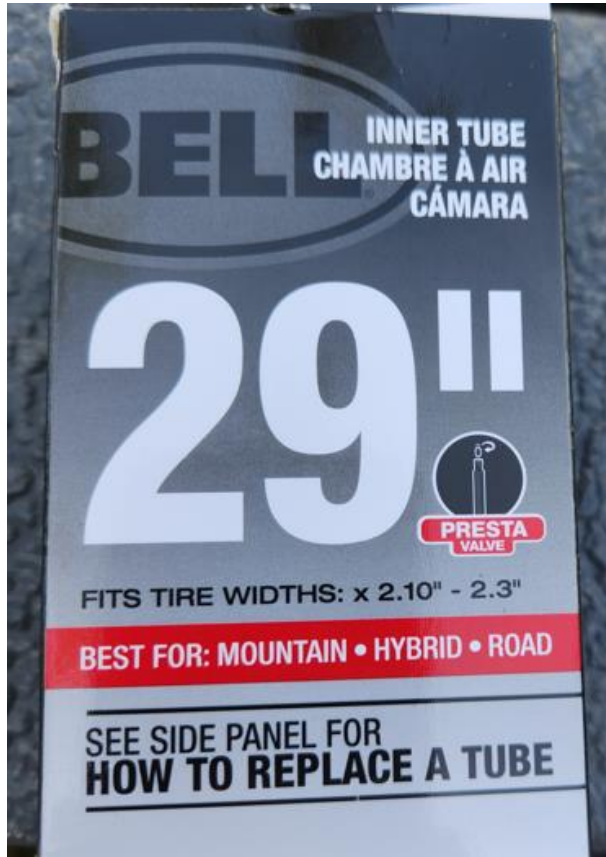
The bicycle inner tube I bought at the hardware store

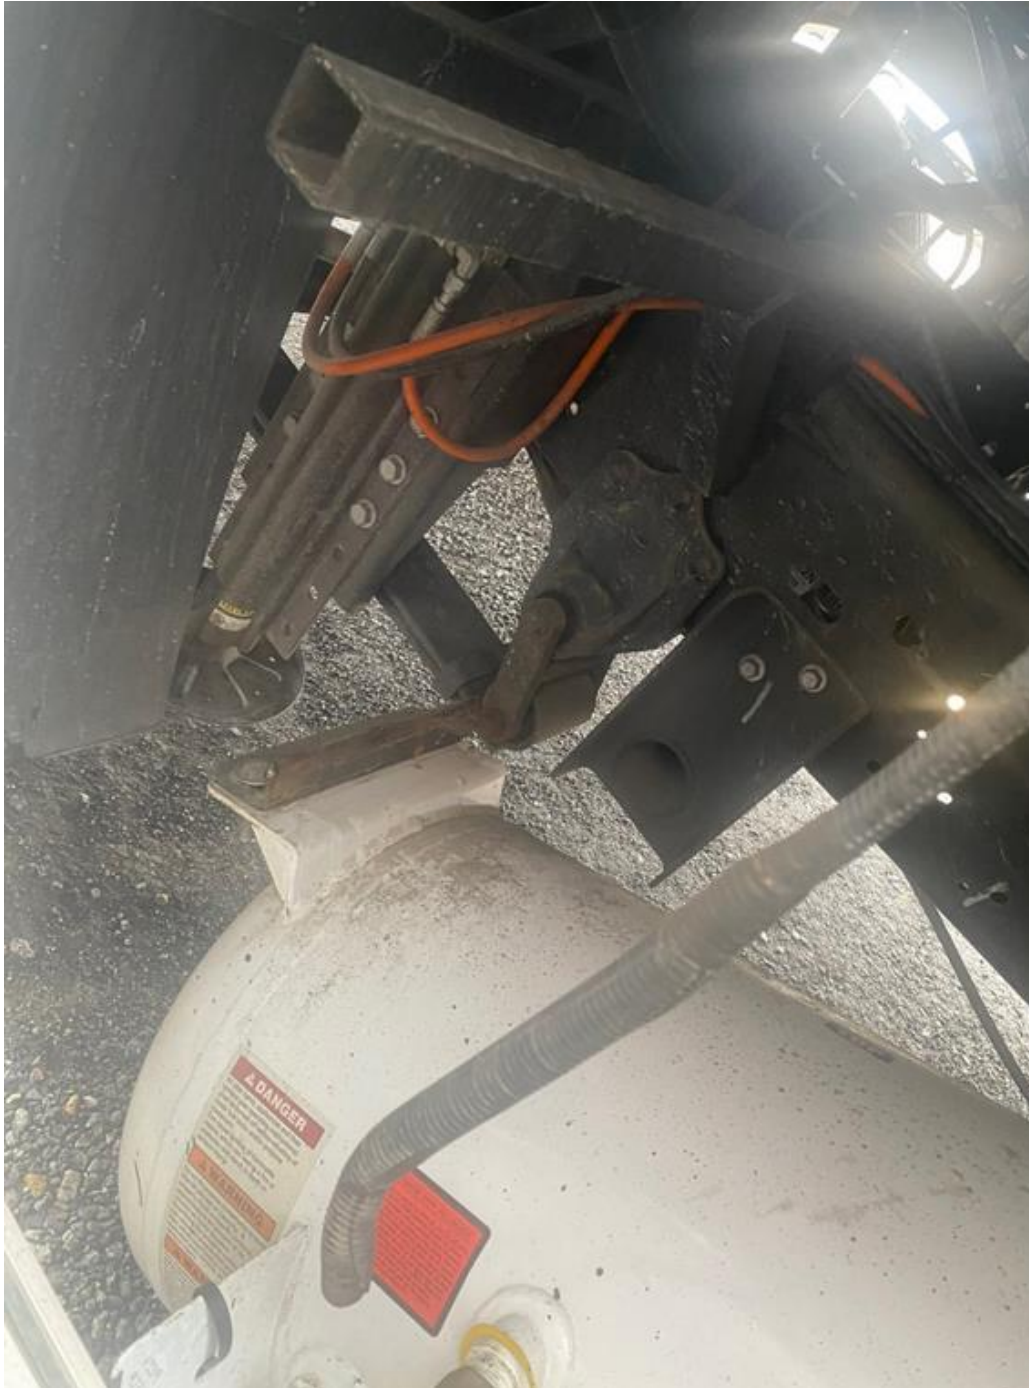
Total weld failure of the front bracket. Note that the 90-degree angle bracket is still bolted to the front of the tank. At least three people posted similar pictures. Two were flagged by passing motorists as they were driving down the road because the motorists saw something white bouncing up and down. One owner reported they had gouges on the bottom of the tank.

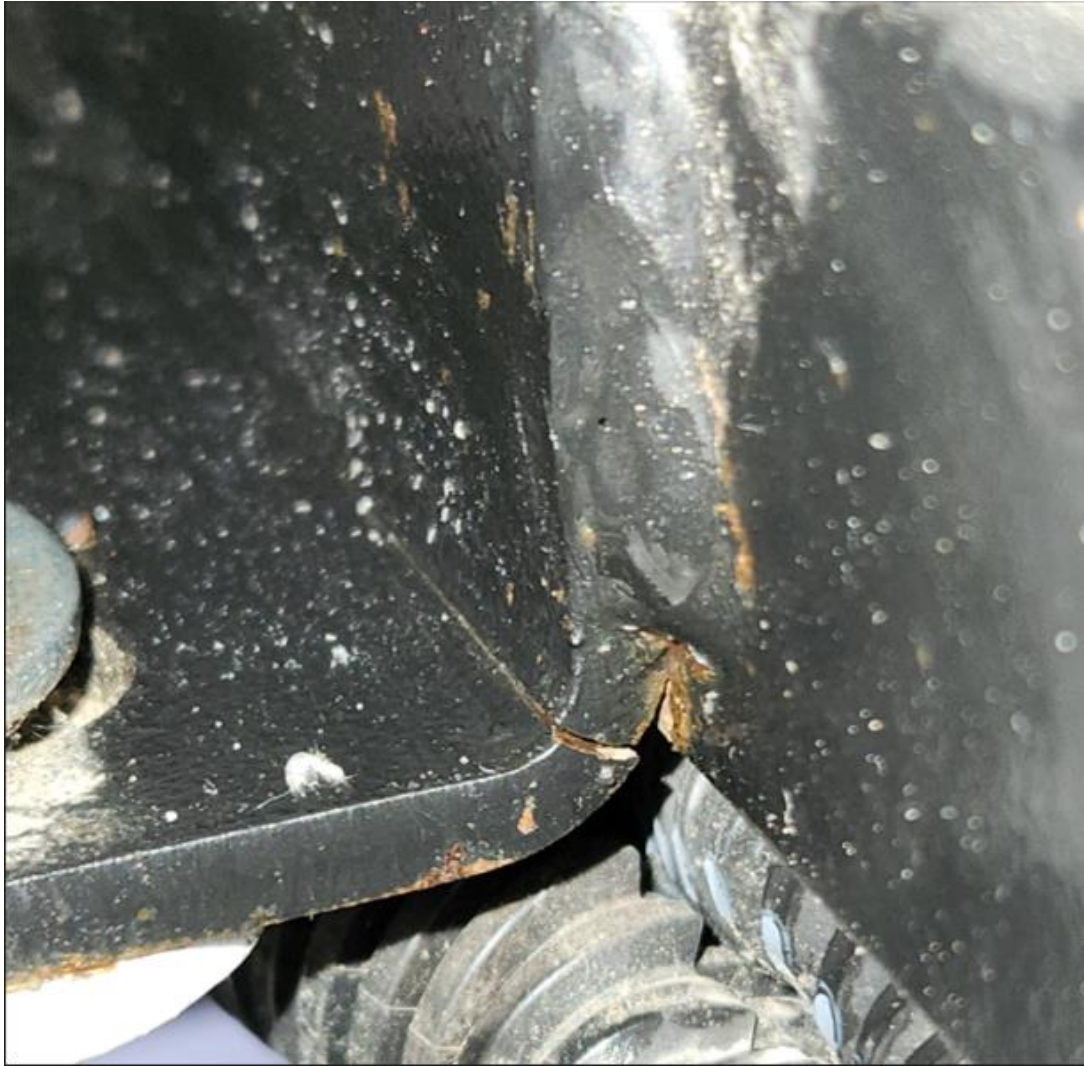
Rear propane mounting bracket crack at the bend on our 2020 GT5 Georgetown. The flexible propane line was tie-wrapped to the support arm and covered the crack. I did not find the crack until someone else reported theirs had cracked. I cut the tie wrap and there it was.

After cleaning and paint removal the crack was found to have extended almost 1/3<sup>rd</sup> of the width of the bracket and was cracked all the way through. Bullet dodged...

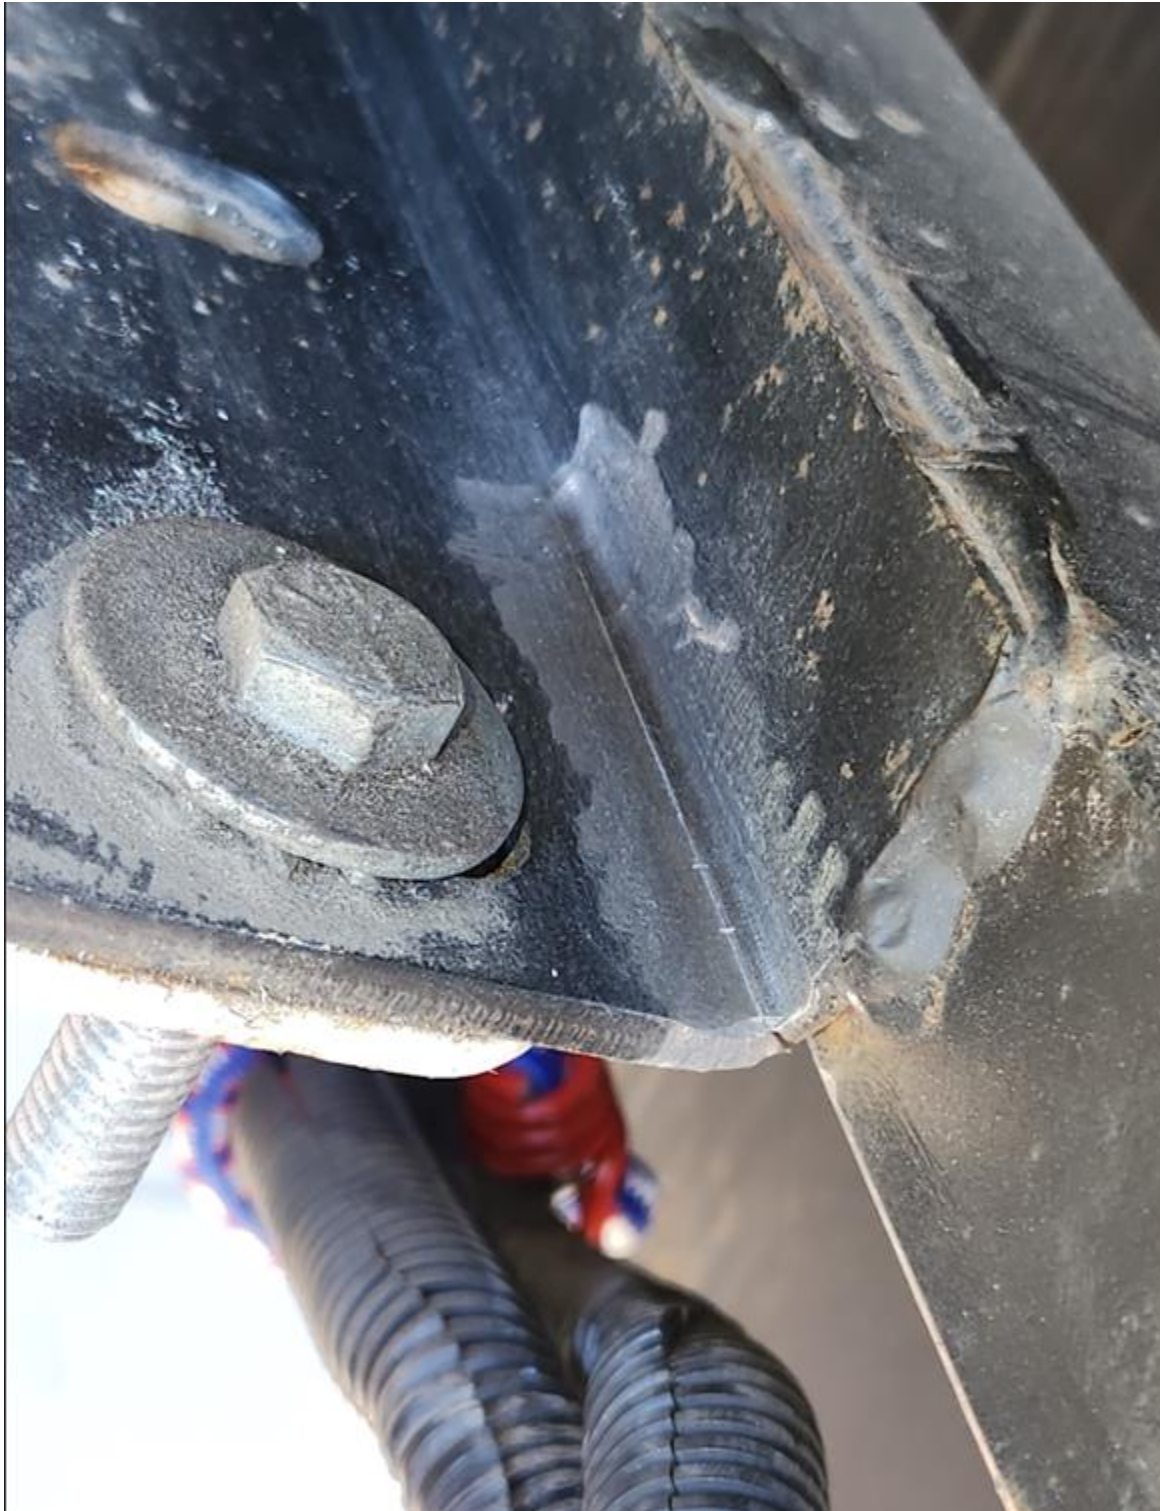
**Note the length of the rear propane mounting bracket crack and its relation to the empty hole in the center of the flange that shows how far the crack had progressed**

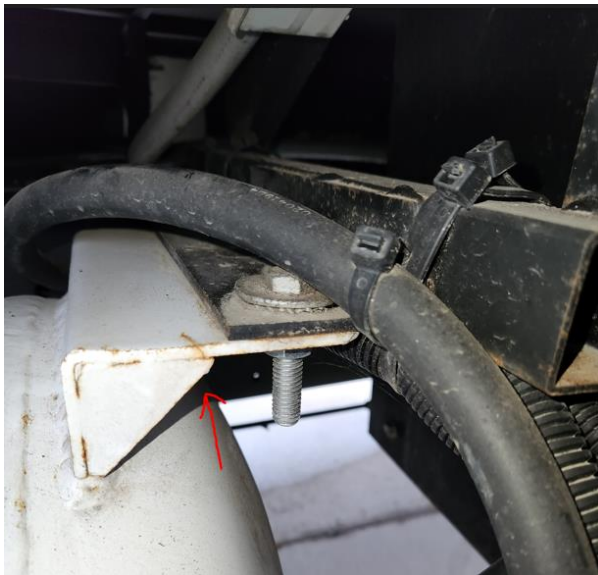
Full-depth crack in the actual propane tank mounting flange just forward of the cracked area in the rear mounting bracket on our 2020 Georgetown. My guess is the tank was bending at the gusset-reinforced area due to up-down movement of the tank. Another owner also reported a crack at that area. The rust in the crack indicates the crack existed for a while.

Note the tie-wrapped flexible propane line behind the bolt head. That is where the crack in the bracket bend was found, hidden by the hose.

*If the rear propane tank bracket cracks all the way through and the rear of the tank falls, the flexible propane line in the picture, being secured with a tie wrap, could tear away at the regulator and propane could spew underneath the motorhome and impinge the catalytic converter and other hot equipment.*

Top of the propane tank mounting flange

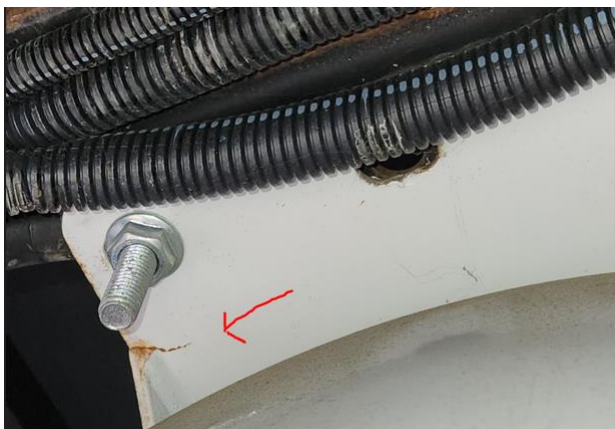
Bottom view showing the crack had progressed all the way through the tank mounting flange

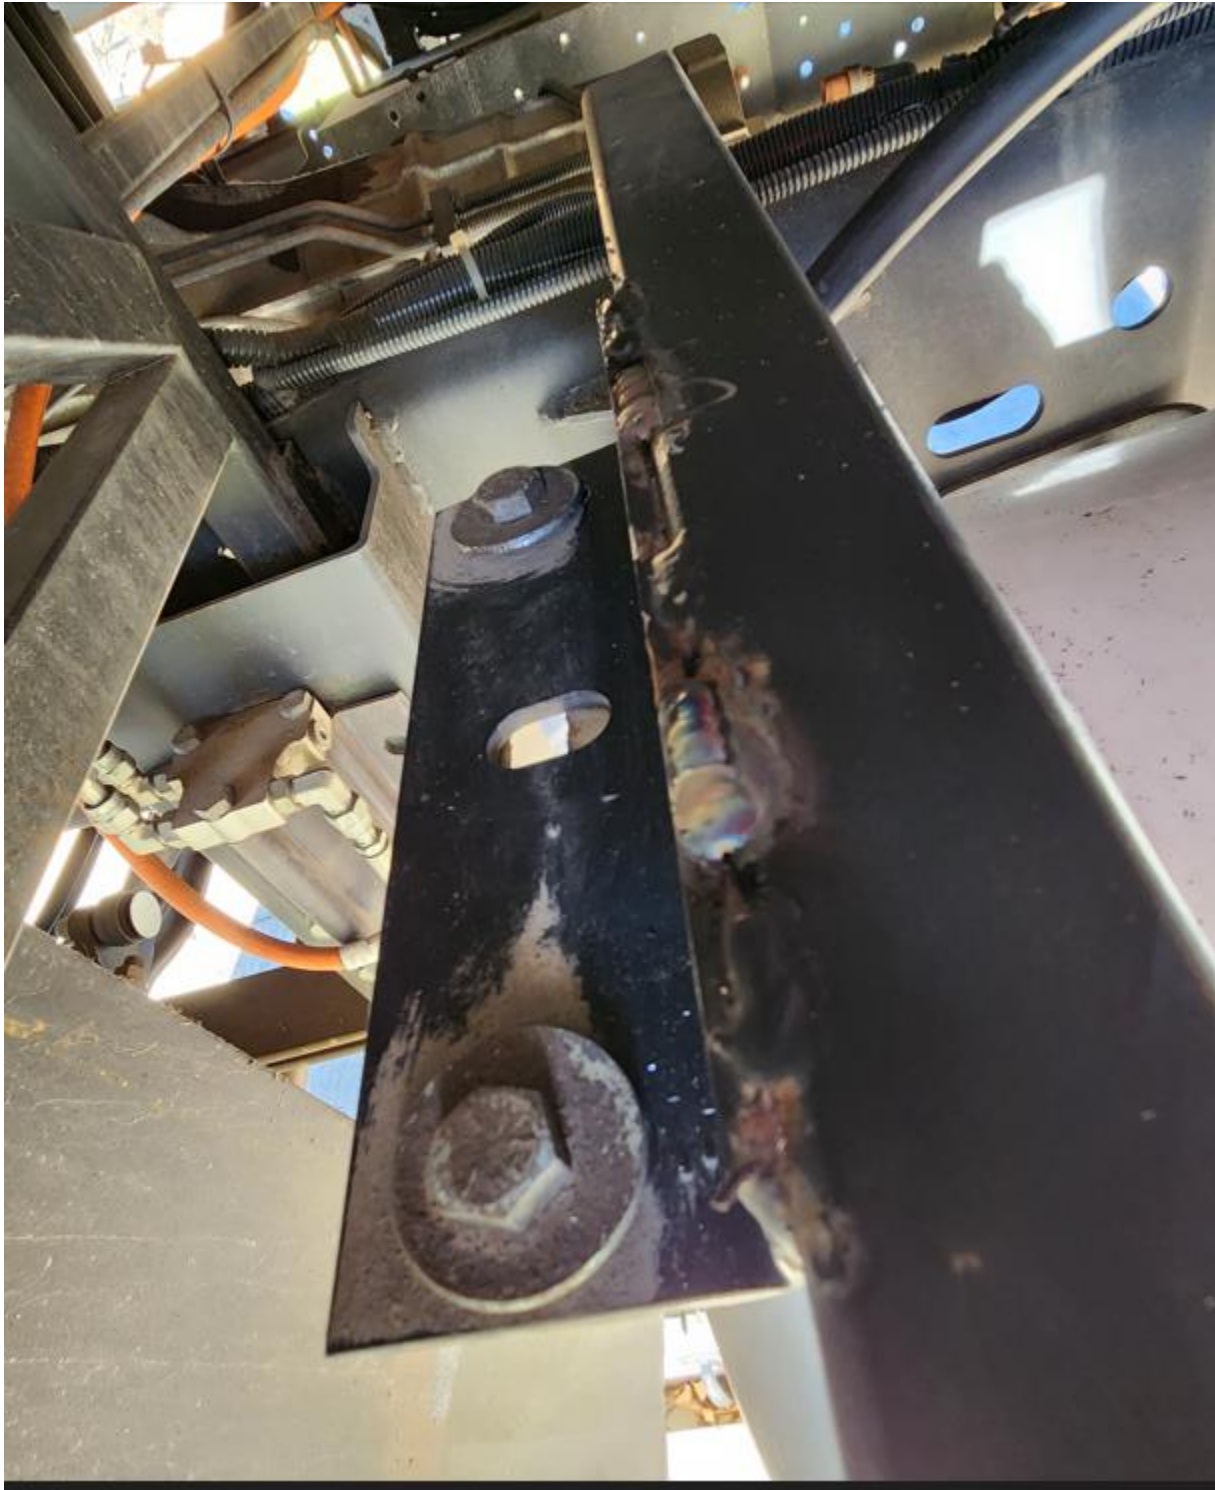
Extra welds added to the top of the front propane tank mounting bracket. This is a difficult area to access and he could not add the triangular gusset plates he wanted to add.
