This program will address the most common system problems associated with the A&E Patio Awnings supplied by The Dometic Corporation. Our intent is to provide you with a guideline of checks to make, should you encounter one of the following symptoms.

SECTION 1 HARDWARE COMPONENTS

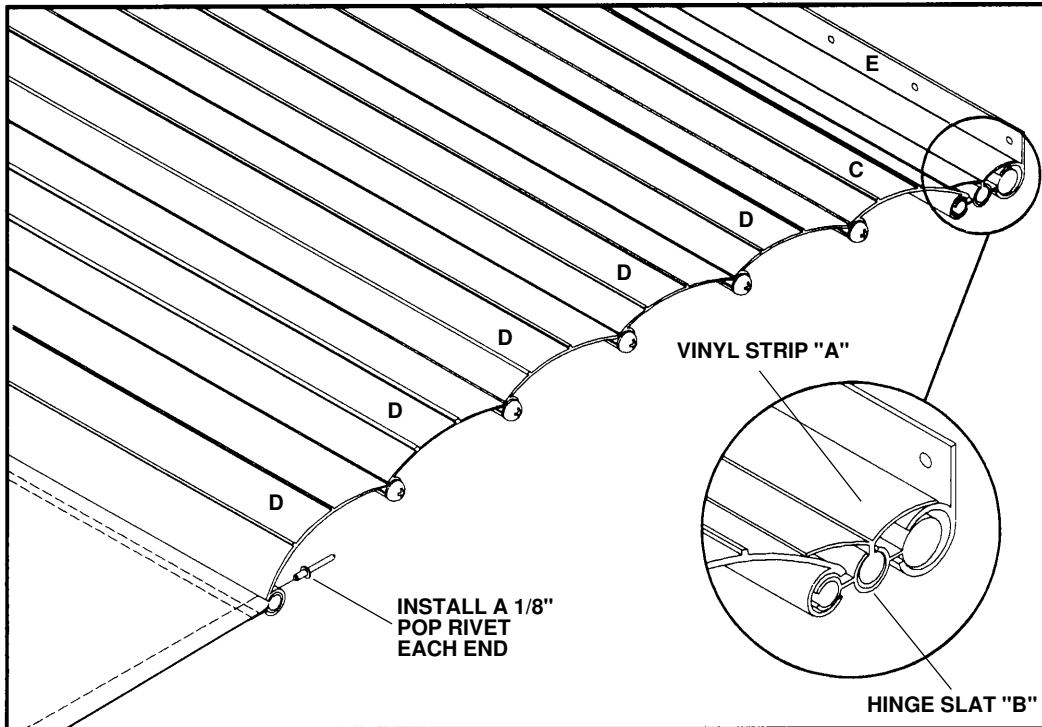
9000 WITH HINGE SLAT

If the roller tube is bent, it will bounce up and down when opening and closing the awning. On the 9000 Series this can cause the aluminum guard to leak, because the guard assembly may not be tight.
